*Class III Cultural Resources Inventory,
Dillon Drive at I-25, Pueblo, Colorado*

FINAL

January 2009

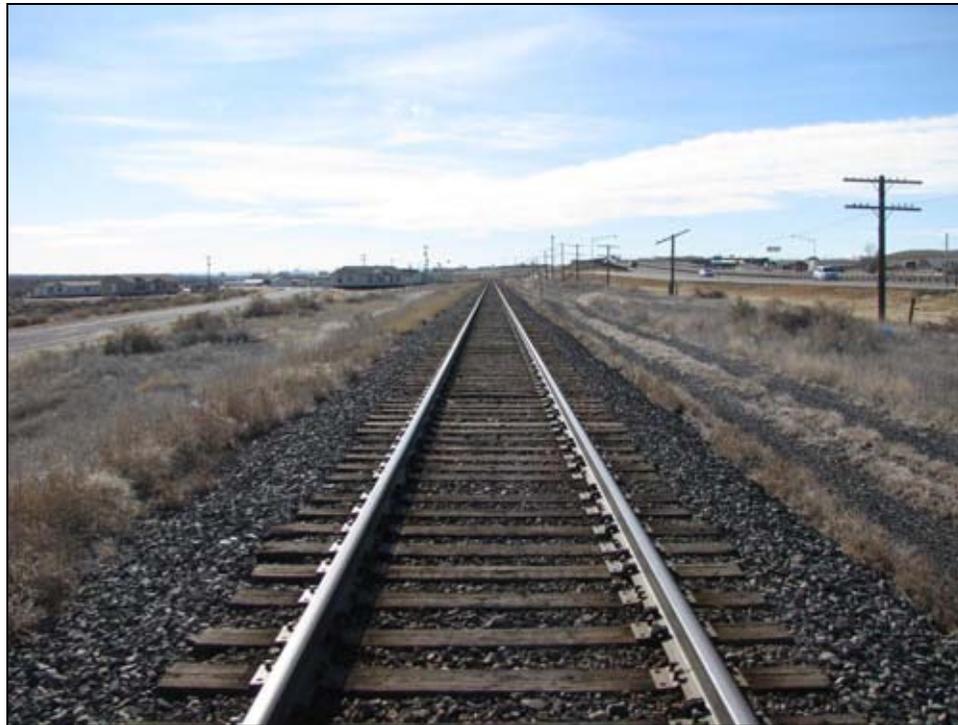
Figure 3. D&RGW Railroad, 5PE1776.12

The entire D&RG (D&RGW) railroad line was determined eligible for the National Register in 1994 under National Register Criterion A. The railroad surveyed is also recommended NRHP-eligible as the first railroad line to arrive to Pueblo in 1872, which encouraged growth and development locally and regionally and had a profound impact to the city's transportation, commerce, and trade in the late nineteenth and early twentieth centuries. The segment of the D&RGW Railroad within the project area supports the eligibility of the overall resource. Although the western track of the D&RGW was removed from the railroad bed in ca. 1943, the remaining eastern track still conveys the history of the railroad line to and from north Pueblo. The railroad's natural setting along the west banks of the Fountain Creek is

intact and conveys the original setting from the early twentieth century. Although Interstate 25 due west of the railroad was built in the 1950s, it does not compromise the D&RGW's setting, feeling, and association as a railroad.

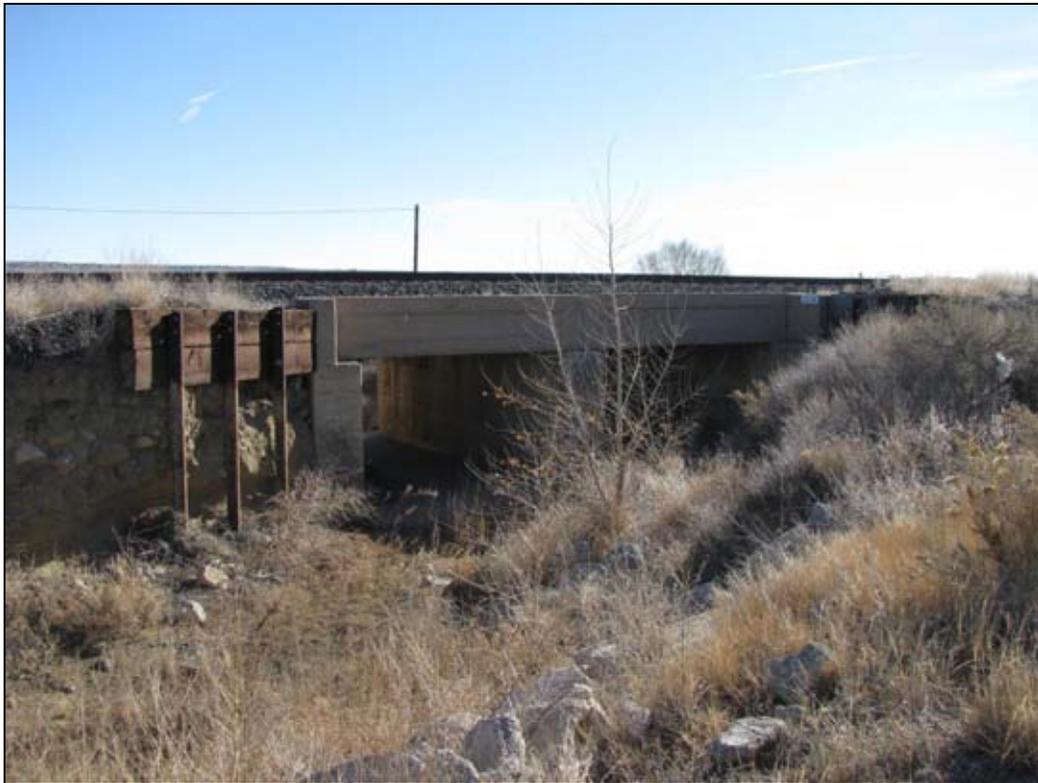
Figure 4. D&RGW Railroad Bridge 112.34, 5PE1776.13

The D&RGW Bridge 112.34 supports the overall eligibility of the D&RGW railroad line by playing a contributing role in the region's development since the bridge was constructed in 1926. The bridge is not recommended eligible under Criterion C due to excessive deterioration. Although the bridge continues to convey its function as a ca.1926 bridge, it no longer serves as a representative example of its type due to

material loss and weathering, such as portions of cracked and spalled concrete that is worn down at the corners and edges. There are missing planks from the horizontal wood-plank wing walls on the west side of the bridge due to age and deterioration. The railroad line over the bridge appears to have been two-track, but the western rails and ties have been removed. As a result, although Bridge 112.34 rises to a sufficient level of significance to support the overall eligibility of the entire D&RGW resource, it is recommended not individually eligible for the NRHP due to loss of integrity.

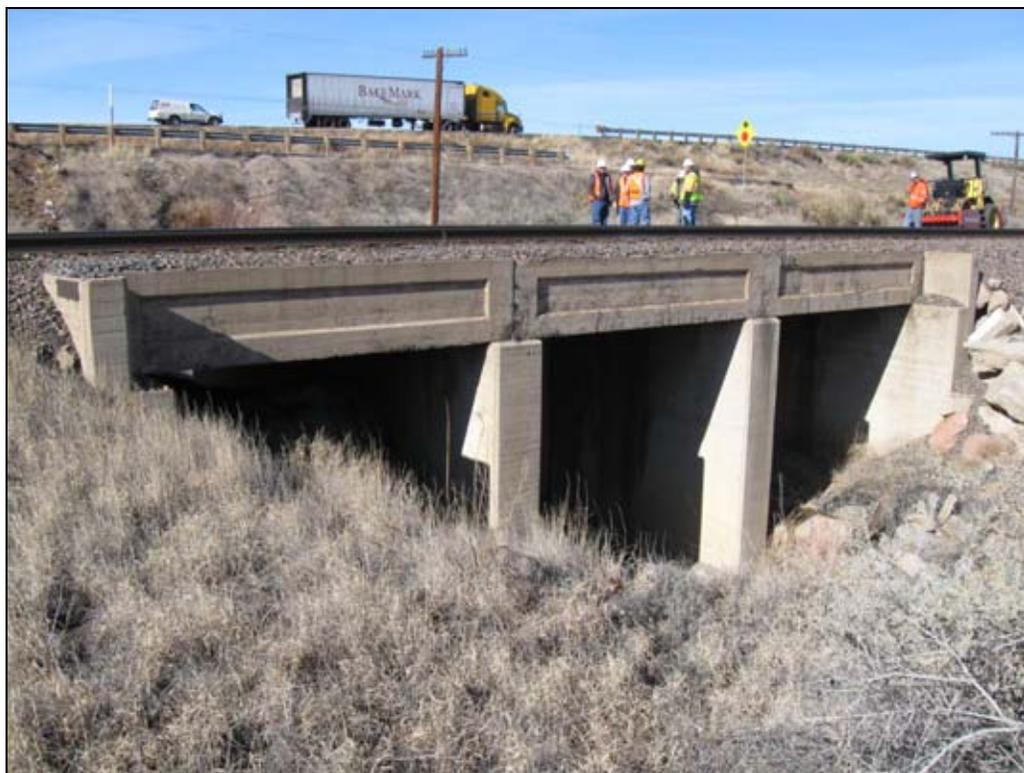
Figure 5. D&RGW Railroad Bridge 112.78, 5PE1776.14

This resource is a concrete, three-span, simple deck bridge that carries the former D&RGW railroad line across an unnamed arroyo. The triple-span is supported by two concrete piers that are each rectangular with vertical sides. The structural beams are closed and the sides of the bridge are cast in three beveled concrete panels. The abutments are vertical walls of solid reinforced concrete. There are no wing walls, but instead the abutments project slightly outward from the bridge deck. The bridge deck is covered by gravel and a single railroad line with rails and ties. The bridge measures 48' long, including three 16' spans, and its deck is 28' wide. It is identified as D&RGW bridge number 112.78.

The D&RGW Bridge 112.78 supports the overall eligibility of the D&RGW railroad line by playing a contributing role in the region's development since the bridge was constructed in 1926. The bridge is not recommended eligible under Criterion C due to excessive deterioration. Although the bridge continues to convey its function as a ca.1926 bridge, it no longer serves as a representative example of its type due to material loss and weathering, such as portions of cracked and spalled concrete that is worn down at the corners and edges. The railroad bridge appears to have been two-track, but the western line's rails and ties have since been removed. As a result, although the D&RGW Bridge 112.78 rises to a sufficient level of significance to support the overall eligibility of the entire D&RGW resource, it is recommended not individually eligible for the NRHP due to loss of integrity.

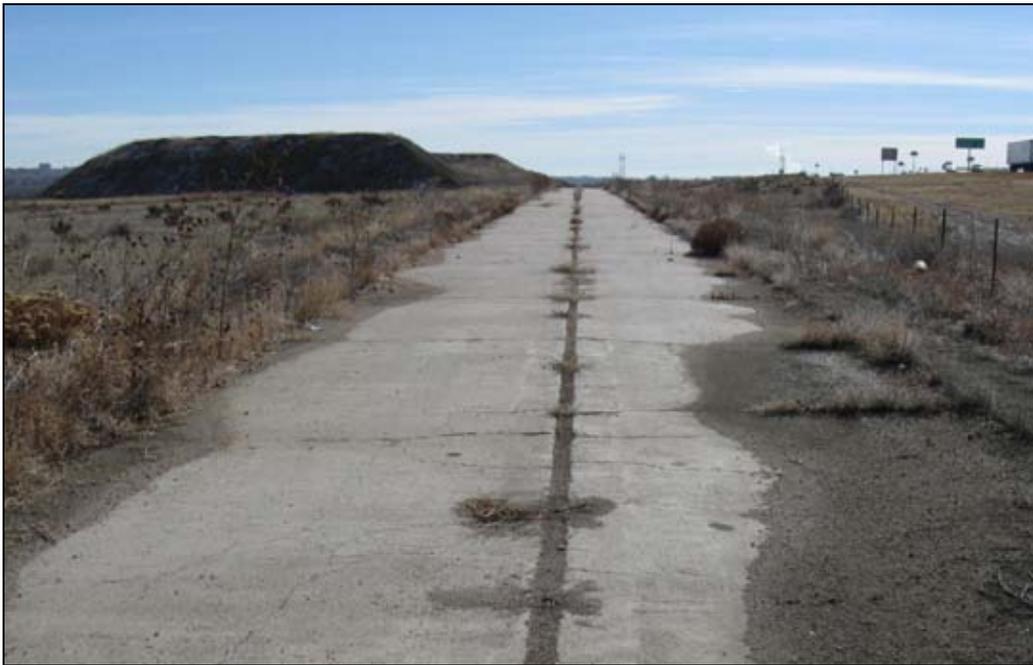
Figure 6. US Highway 85, SPE6890.1

comes to an abrupt end at its northern edge, where it appears to have been cut to accommodate the construction of I-25 and its right of way, due west.

US 85 played an important role in the urbanization of Colorado as part of the first paved, interstate route that ran north-south through Colorado from Wyoming to New Mexico as early as 1930. As such, the abandoned linear segment of US 85 is recommended eligible for the National Register under Criterion A as an important transportation artery on the Front Range, and its contribution to the urbanization, commerce and trade, and transportation history of Colorado between 1930 and 1961, when it was replaced or covered by I-25 along the same route. This abandoned 1,040-foot-long segment of US 85 north of Pueblo supports the overall eligibility of the former US 85 resource in Colorado. Although weathered and cracked due to age and lack of maintenance, this segment maintains its integrity as a roadbed, and conveys its early history as an early interstate highway in Colorado. Moreover, although other abandoned segments of US 85 have been previously recorded in Las Animas, CO, and near Colorado Springs, CO, (which has been officially determined eligible to the National Register), this segment appears to be the first recorded segment of the former US 85 roadway in Pueblo County.

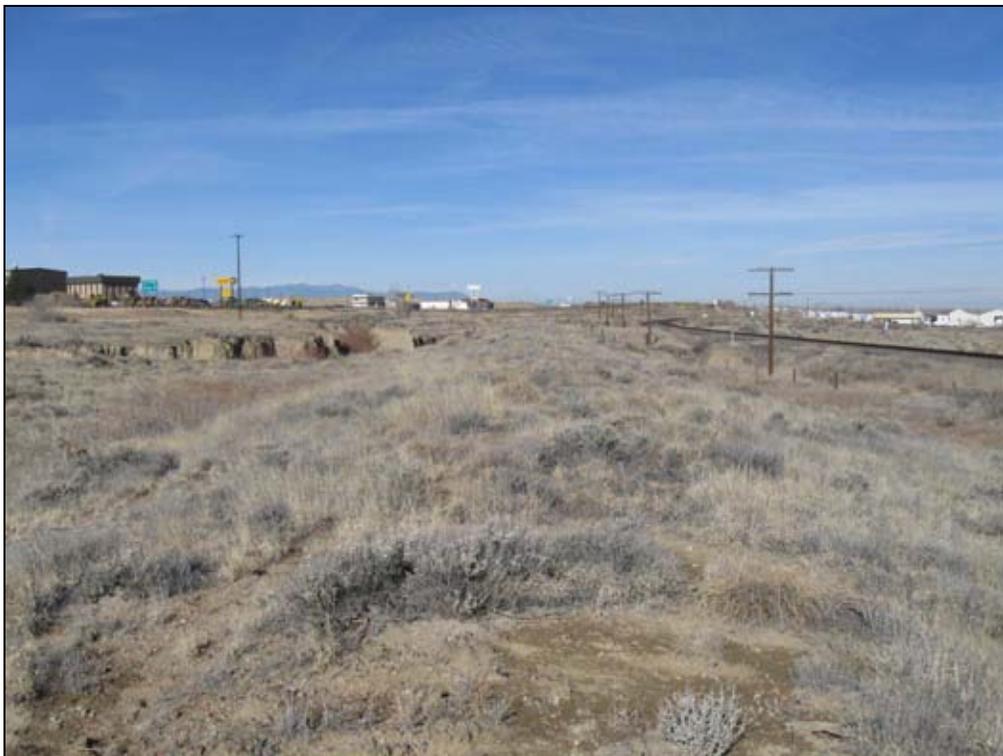
Figure 7. Abandoned AT&SF Railroad, 5PE1665.12

This resource consists of an abandoned railroad bed of the AT&SF Railroad, and extends within the survey area approximately 1,700 feet and continues outside of the survey area for an undetermined distance to the south. The remnants of the bed point in a north-northwest direction, and parallel with the D&RGW railroad line, due east. The former railroad bed is nearly worn away due to age and the elements. All of the railroad rails, ties, and gravel have been removed from the site. The site currently exists as a slightly raised berm that is overgrown with vegetation.

Although the AT&SF Railroad has been determined eligible to the National Register under National Register Criterion A, this abandoned segment of the AT&SF line does not support the eligibility of the overall resource. This line was realigned and the tracks removed sometime before 1916. (This is not to be confused with the western D&RGW tracks, which were removed in ca. 1943.) Since then the former AT&SF railroad bed has nearly completely eroded, and has severely lost its integrity and its ability to convey its former use as a railroad bed. As a result, this segment is not recommended eligible for nomination to the National Register due to loss of historic physical integrity.

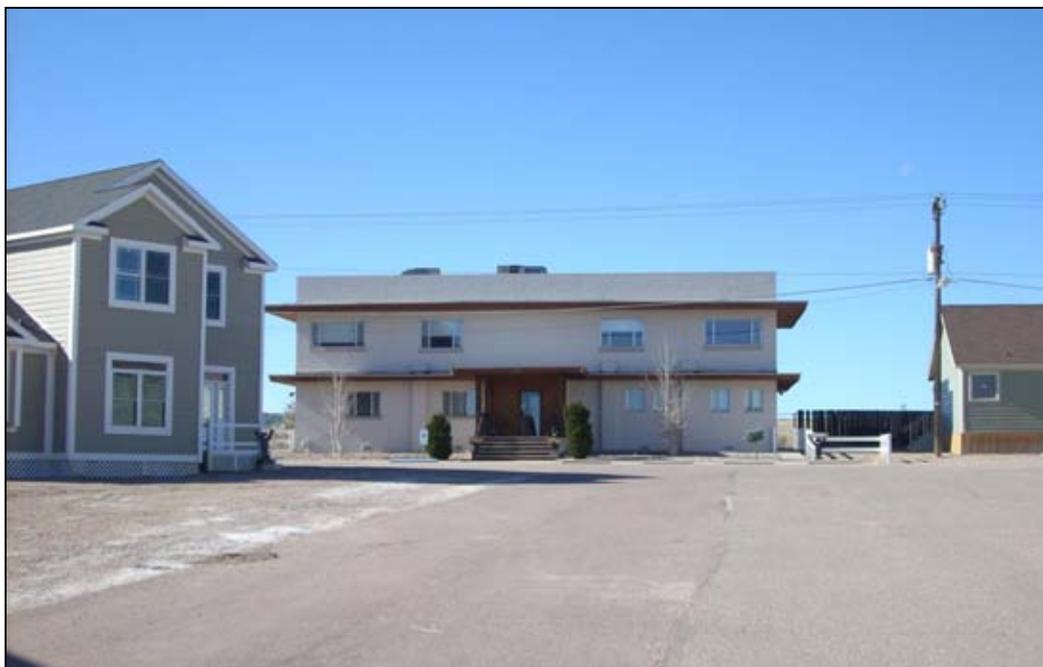
Figure 8. 2335 N. Interstate 25, 5PE6891

This property consists of two permanent commercial buildings and three temporary mobile homes. The primary building is located at the west side of the property, and is a two-story, concrete-block office building that was built in 1965. The secondary building on the property is a two-story, metal-framed service building that was built in 1978. Four temporary or mobile homes on the property appear to be added within the past ten years or less.

The buildings at 2335 N. Interstate 25 are recommended to be not eligible for nomination to the NRHP because they do not meet Criterion Consideration G for properties less than 50 years of age with exception significance. Historical research does not indicate that the primary and secondary (1965 and 1978, respectively) buildings are associated with important historical events or historically important people, and thus do not meet Criteria A and B. They are not exceptional for their architectural merit, and therefore do not meet Criterion C.

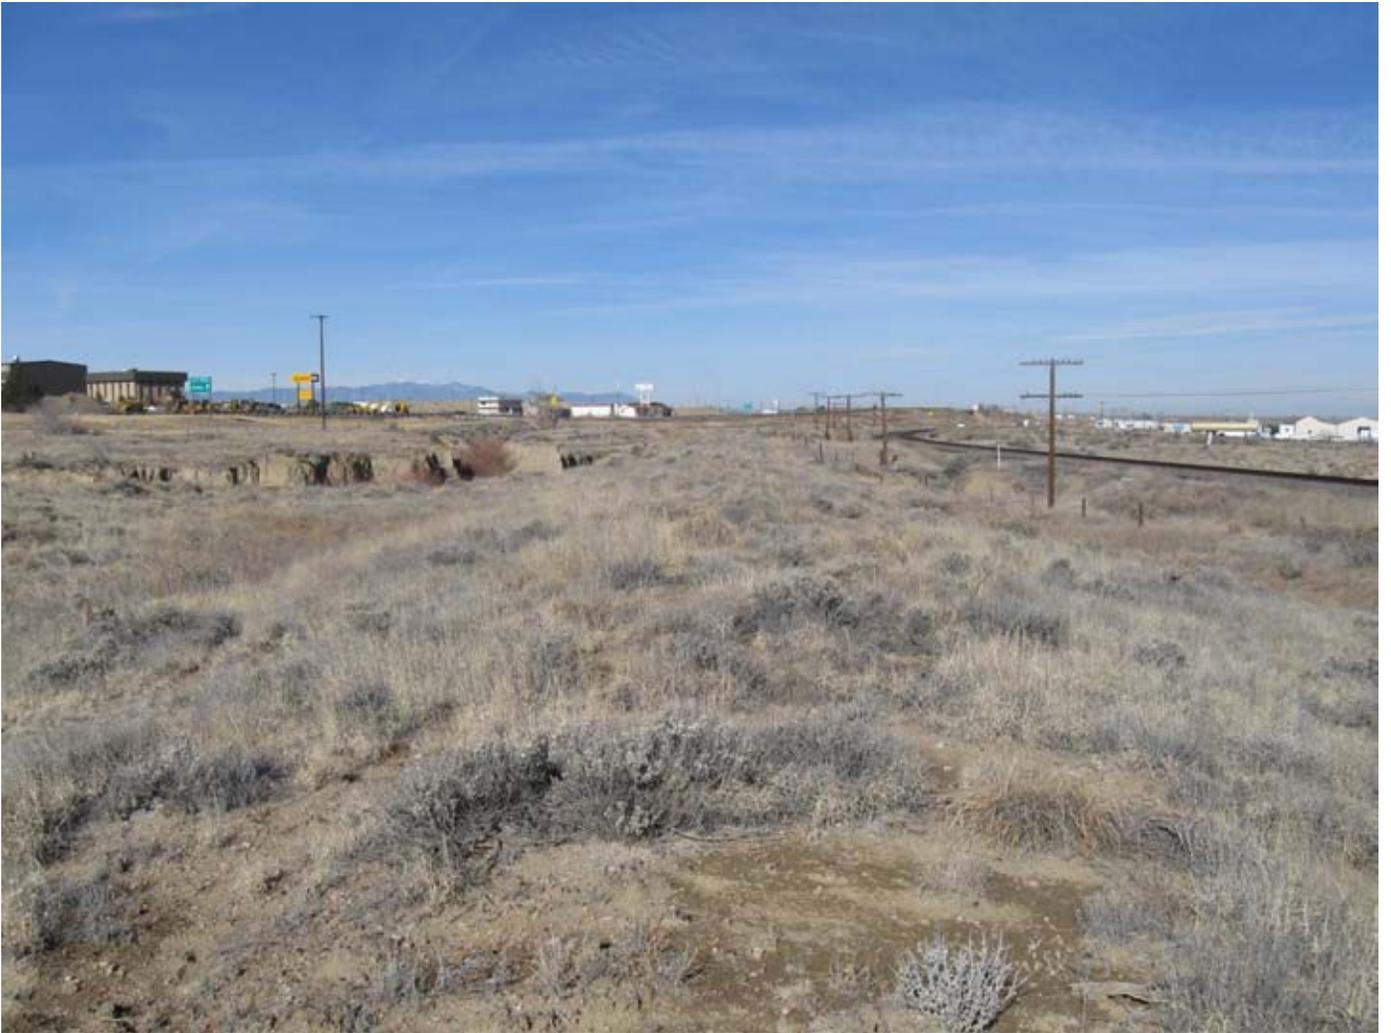
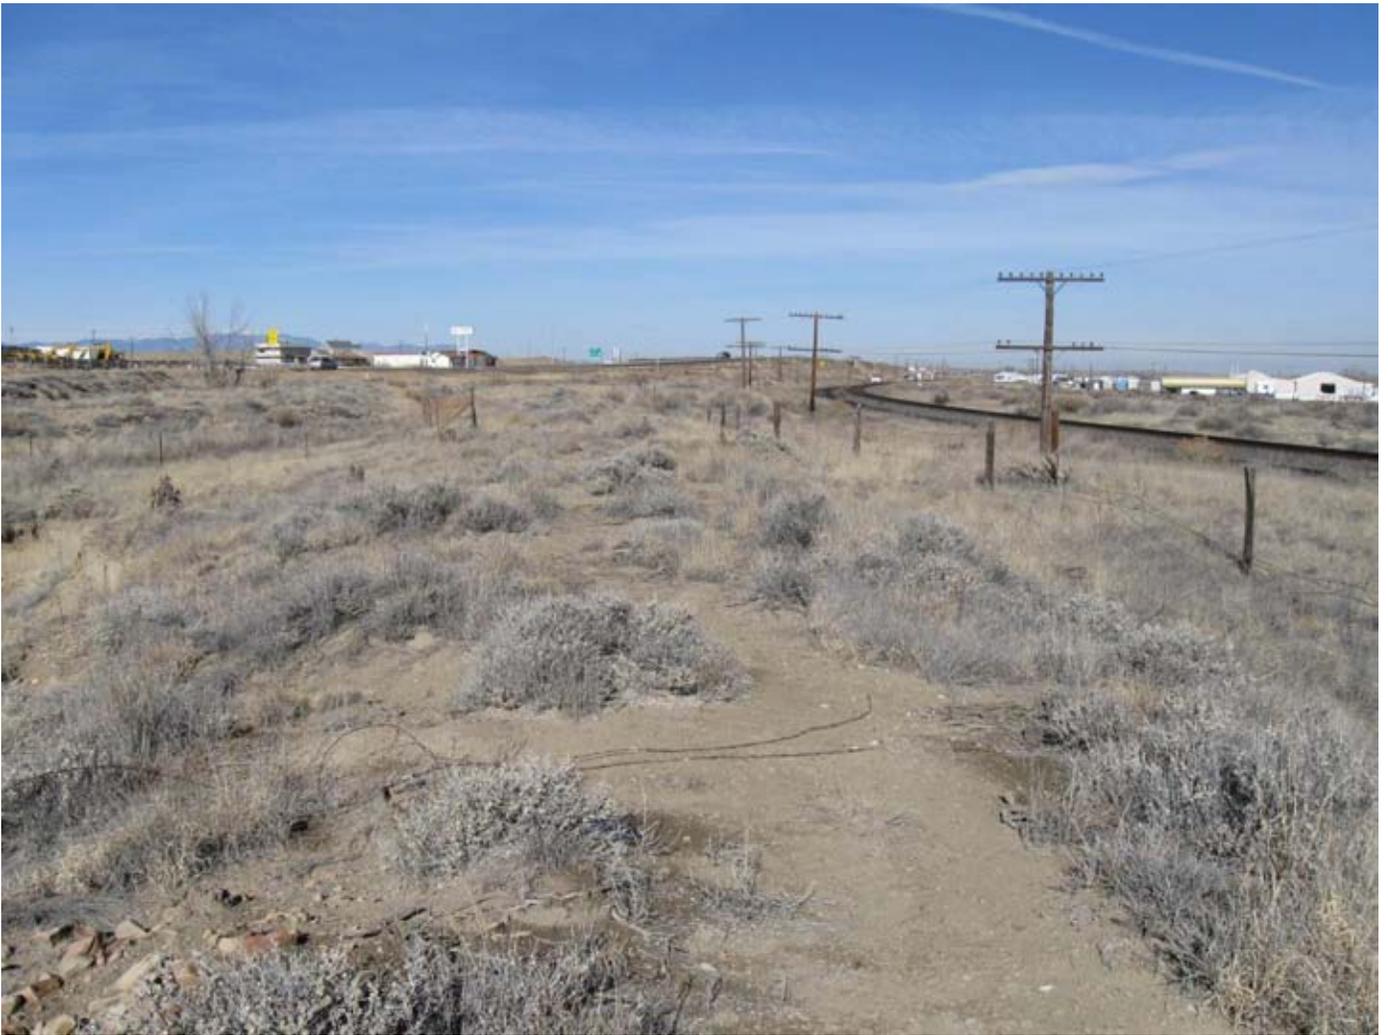
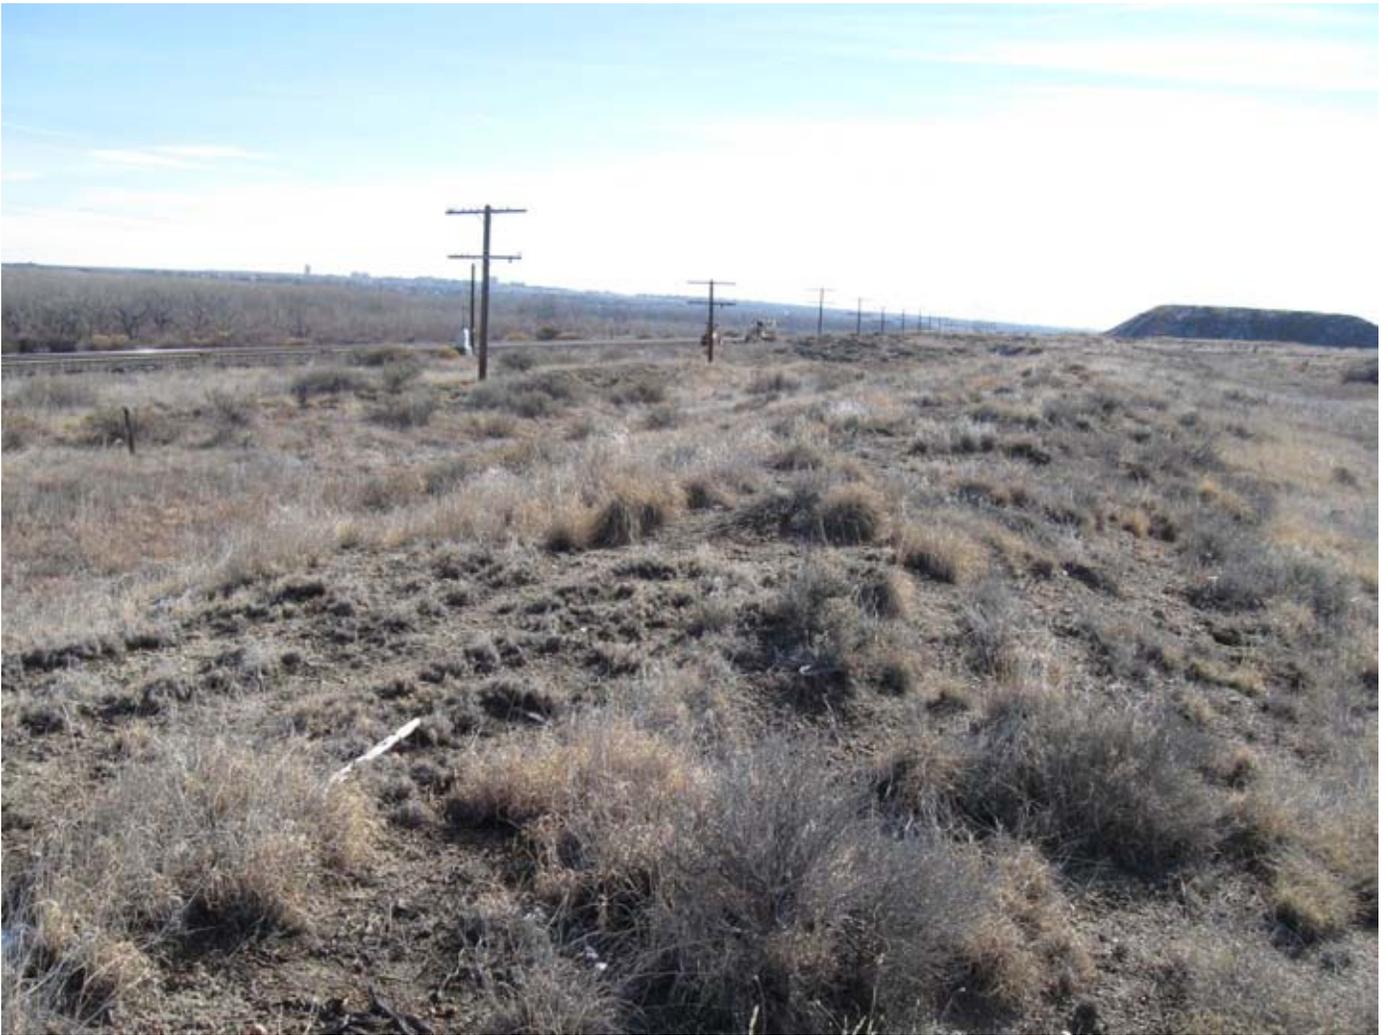
34. Describe condition: The former AT&SF railroad bed is nearly worn away due to age and erosion. All of the railroad rails, ties, and gravel have been removed from the railroad bed, and the remaining berm has worn down substantially. The site currently exists as a slightly raised berm that is overgrown with vegetation. No evidence of former trestles were identified at the arroyos during field survey.

Photograph 1: AT&SF Railroad Bed, View to the north-northwest.

Photograph 2: AT&SF Railroad Bed, View to the north-northwest.

Photograph 3: AT&SF Railroad Bed, View to the southeast.

39. Threats to Resource: Water erosion___ Wind erosion X Grazing___ Neglect X
Vandalism___ Recreation___ Construction___ Other (specify): _____
comments: _____
40. Existing Protection: None X Marked___ Fenced___ Patrolled___ Access controlled ___
other (specify): _____
41. Local landmark designation: n/a 42. Easement: n/a
43. Management Recommendations: No further work.

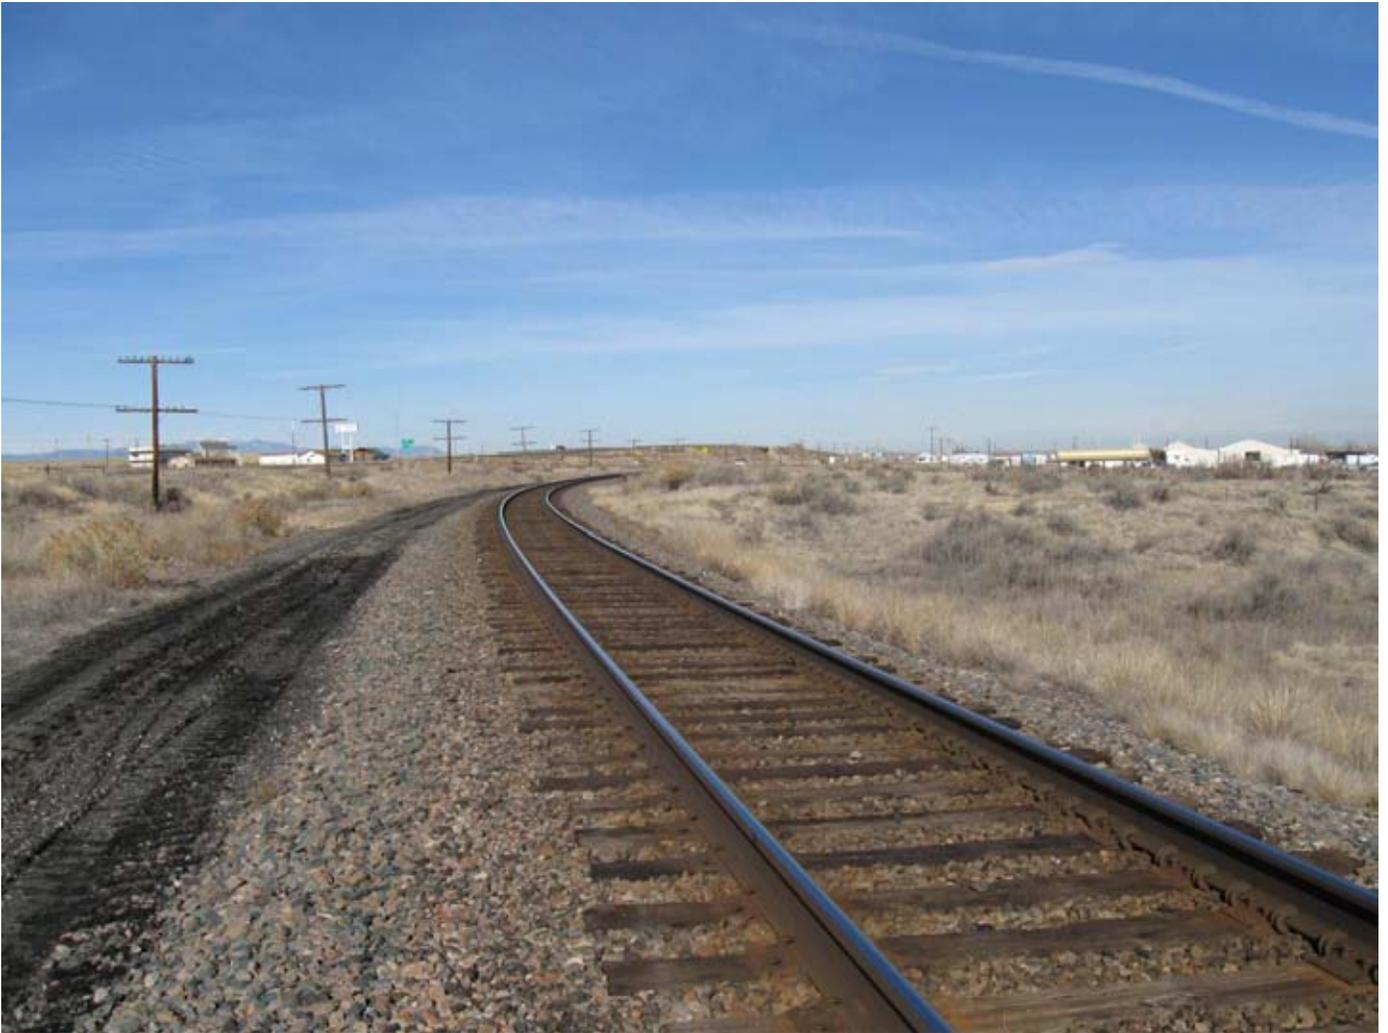
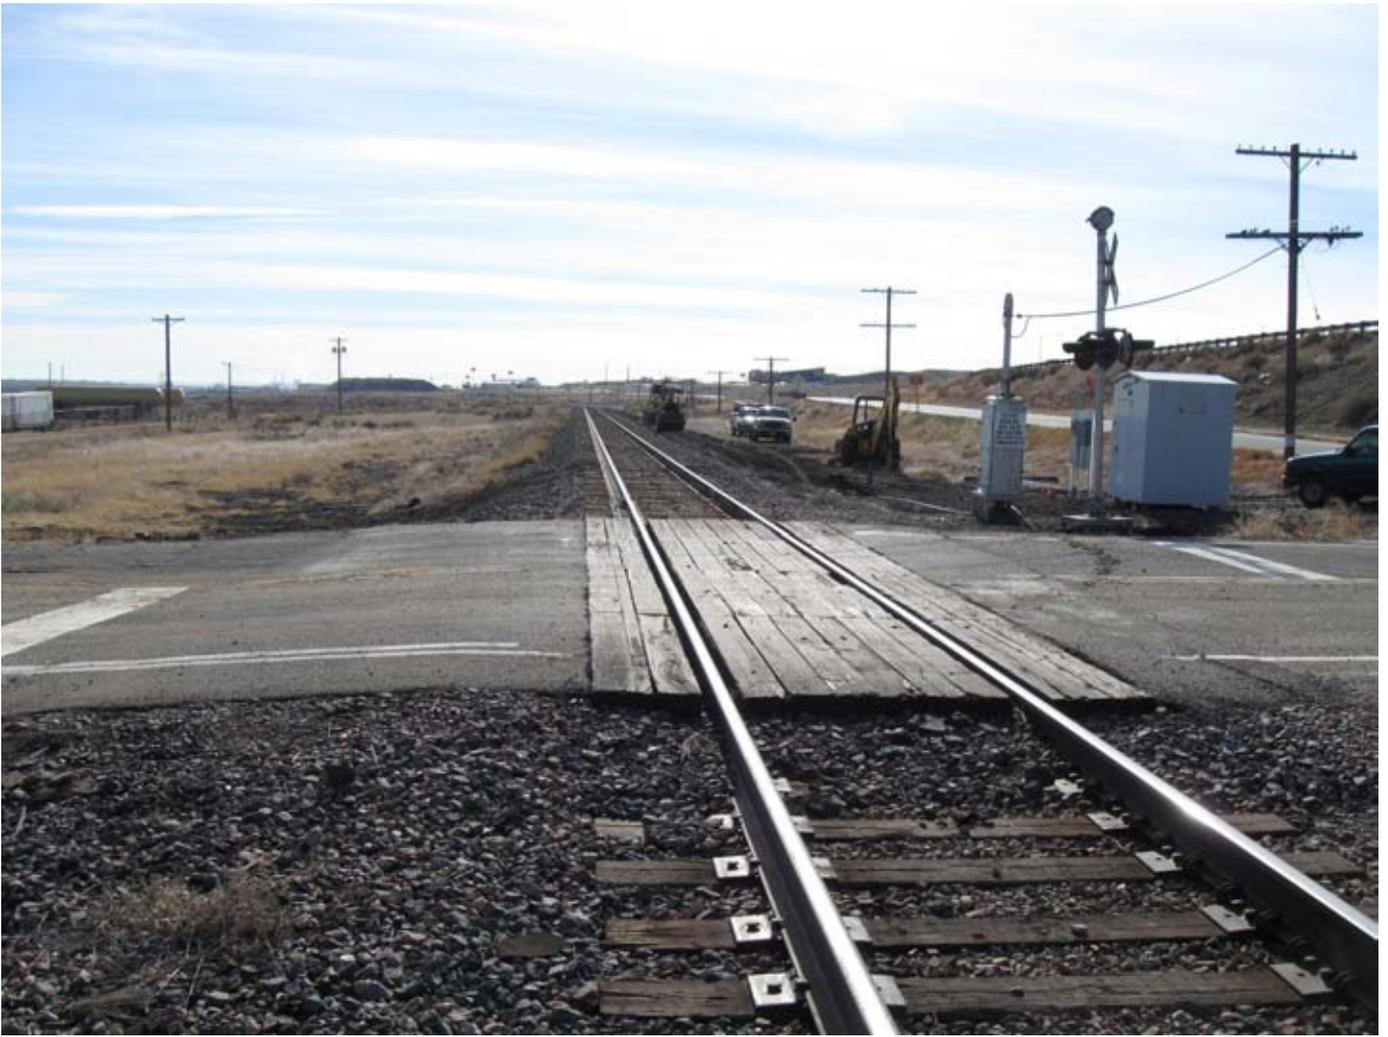
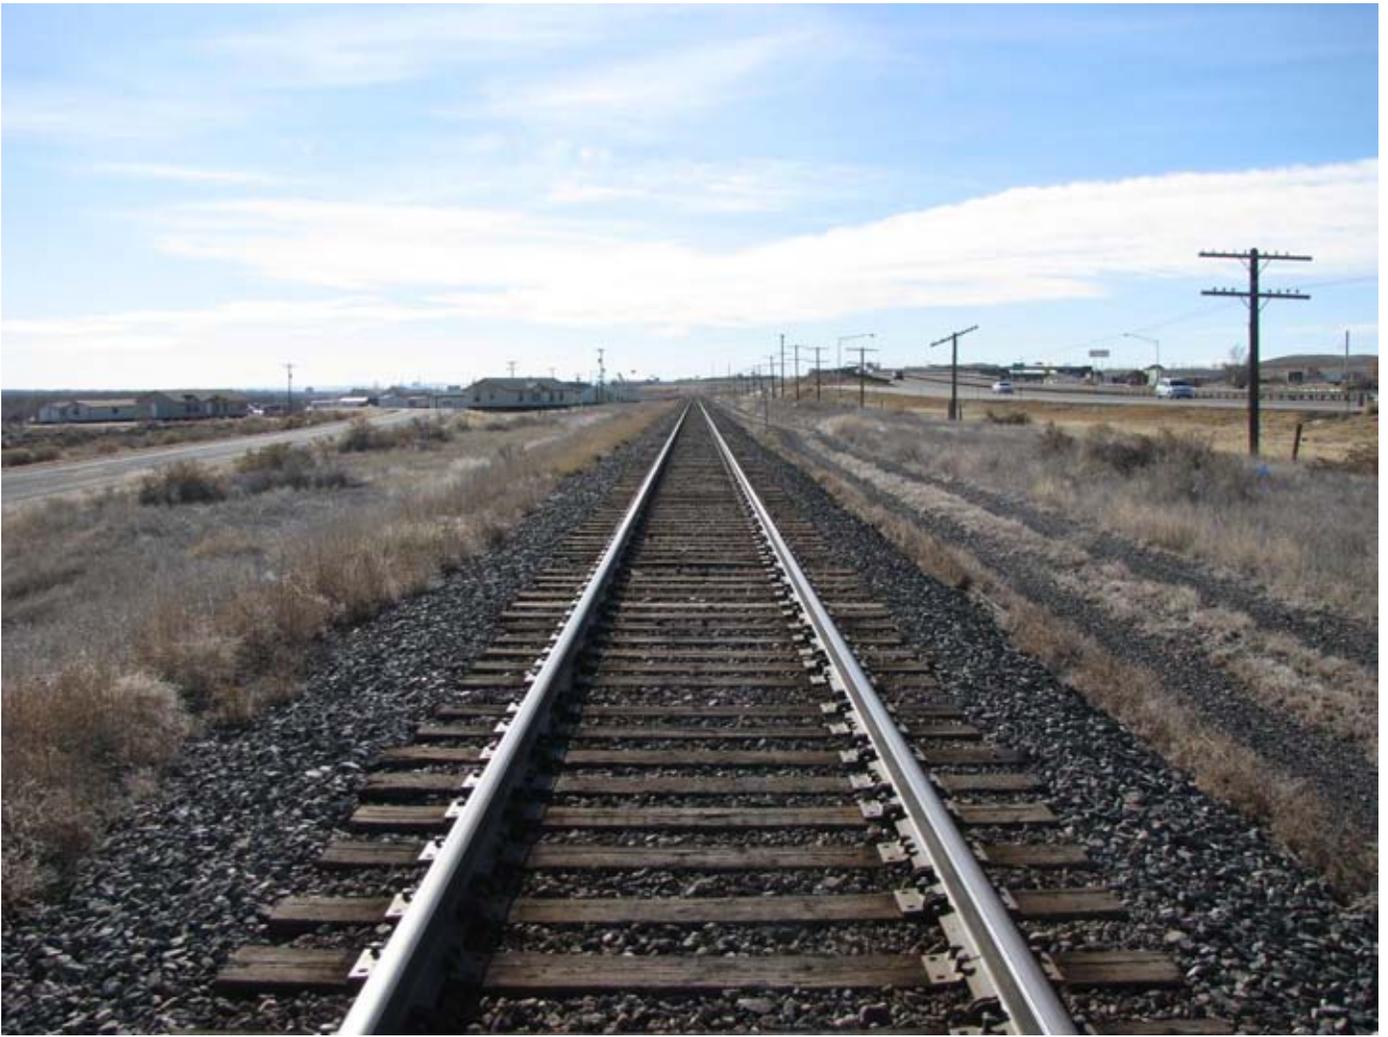
34. Describe condition: This resource is a 4,300-foot-long active segment of the former D&RGW railroad, and is currently operated and maintained by the Union Pacific Railroad. The tracks, ties, and all associated features are in good working order.

Photograph 1: D&RGW railroad, View from the south end of the segment, looking northwest.

Photograph 2: D&RGW railroad at Pace Road, looking south-southwest.

Photograph 3: D&RGW railroad, View from the north end of the segment, looking south.

39. Threats to Resource: Water erosion___ Wind erosion___ Grazing___ Neglect___
Vandalism___ Recreation___ Construction___ Other (specify): _____
comments: No threats observed.
40. Existing Protection: None___ Marked___ Fenced___ Patrolled X Access controlled ___
other (specify): Railroad is monitored by the Union Pacific Railroad Company
41. Local landmark designation: n/a 42. Easement: n/a
43. Management Recommendations: Avoid, otherwise no further work.

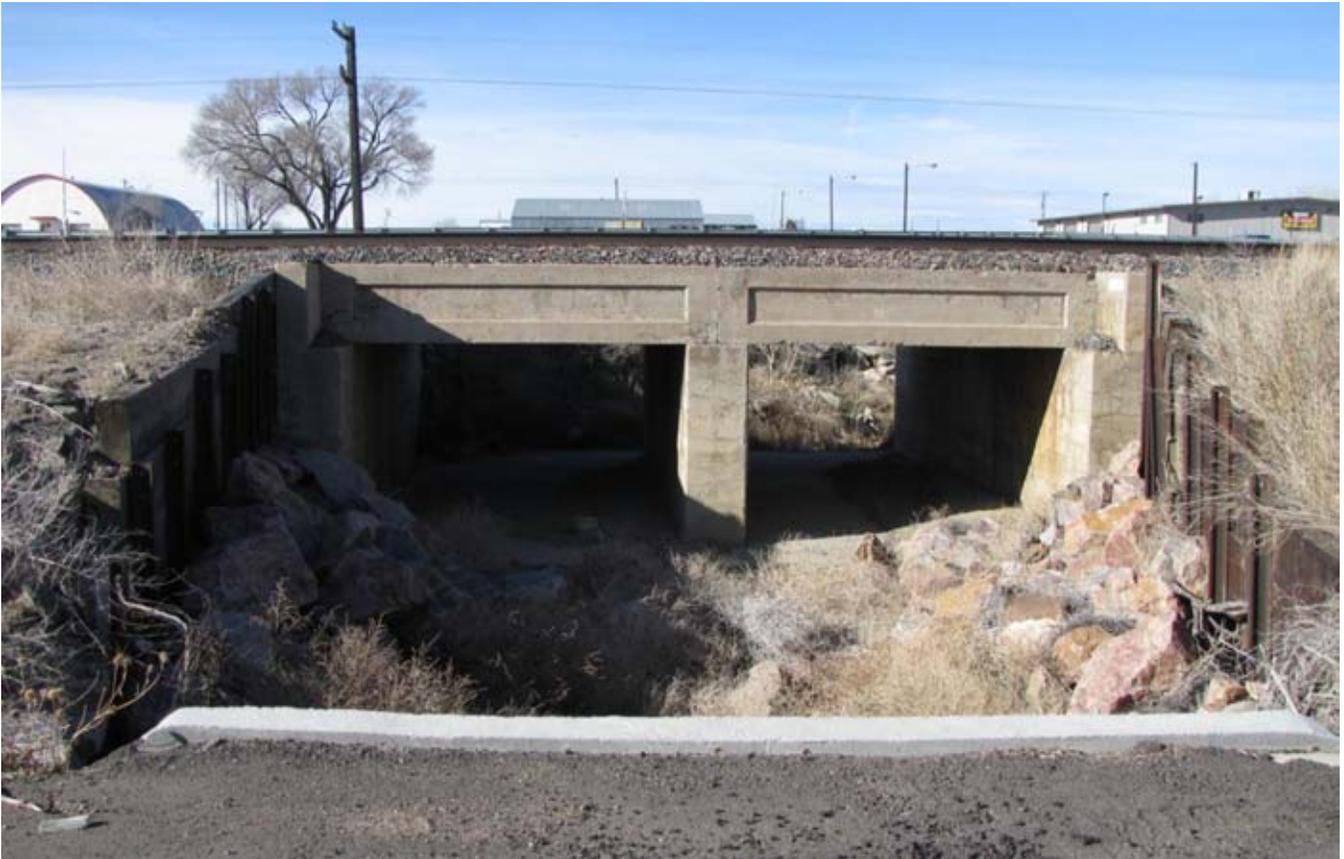
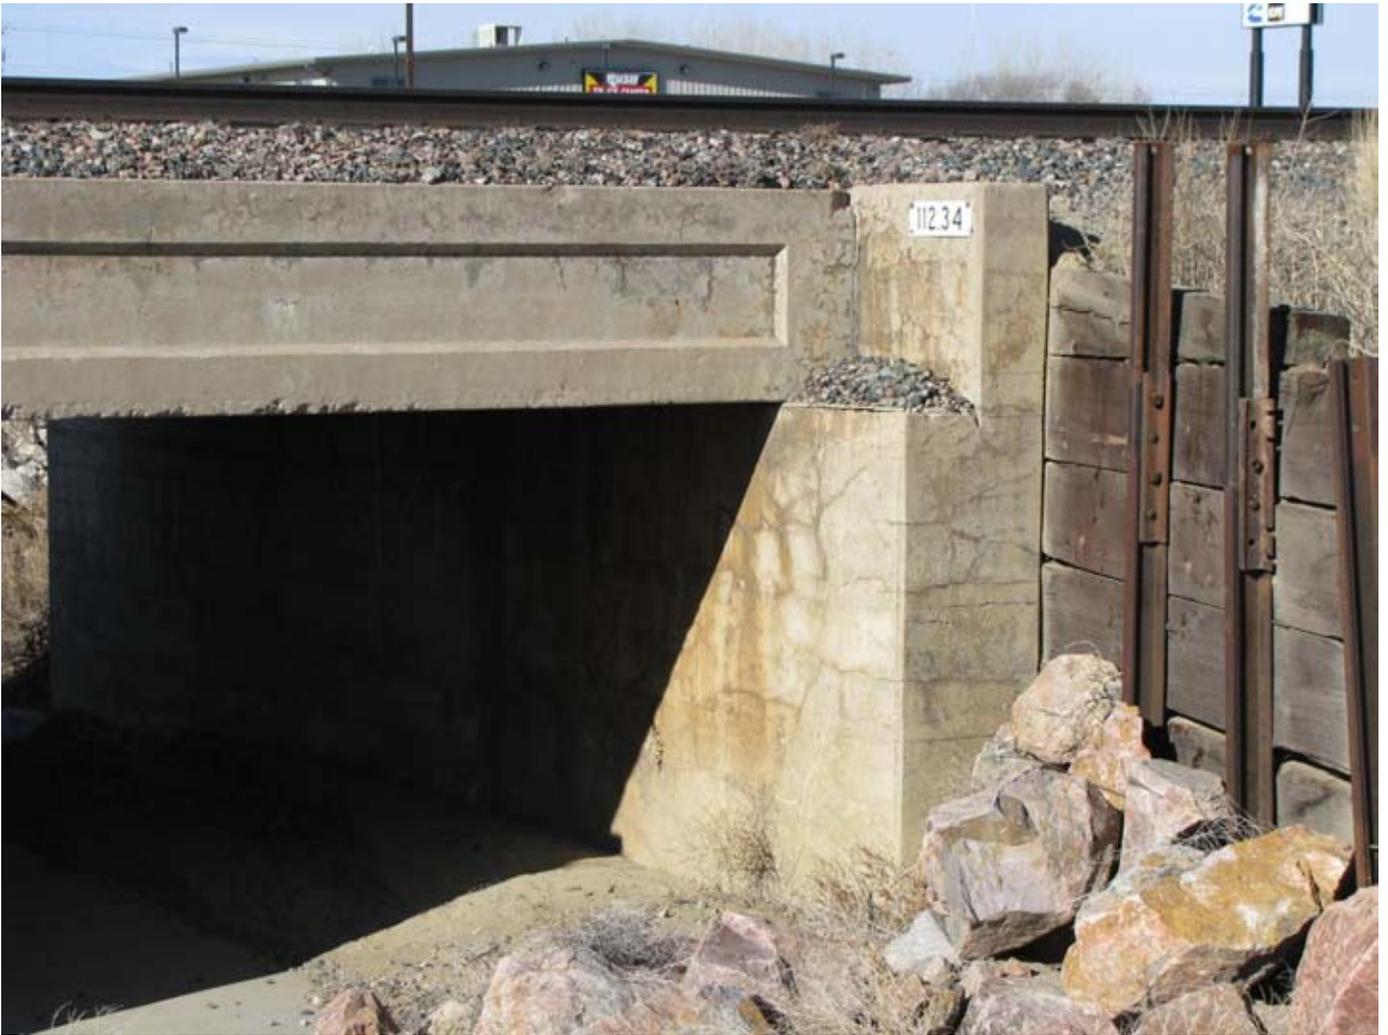
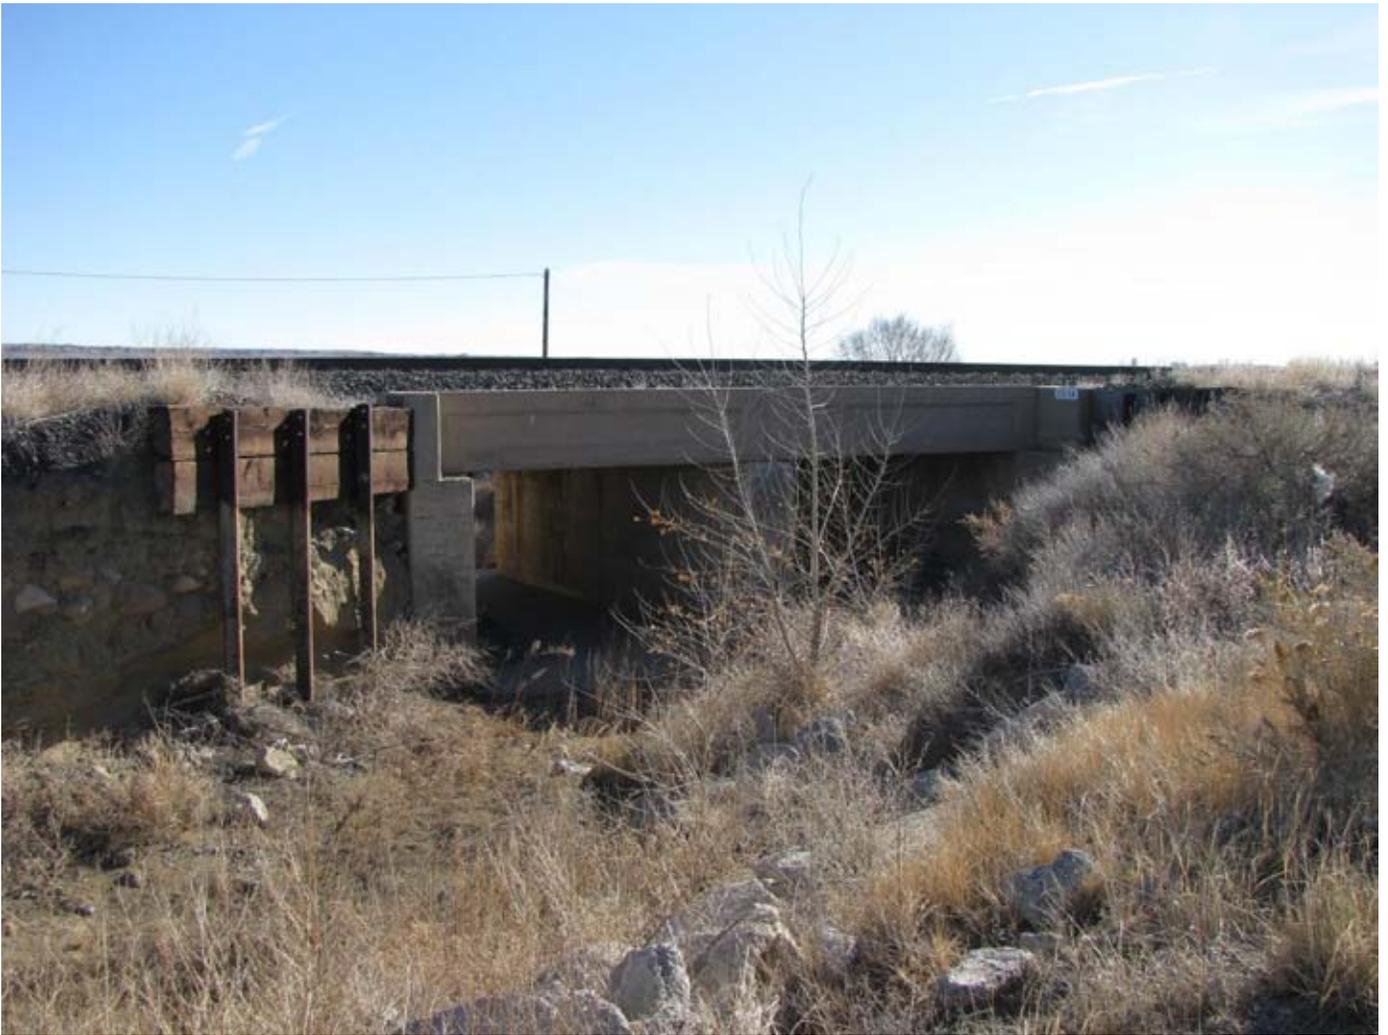
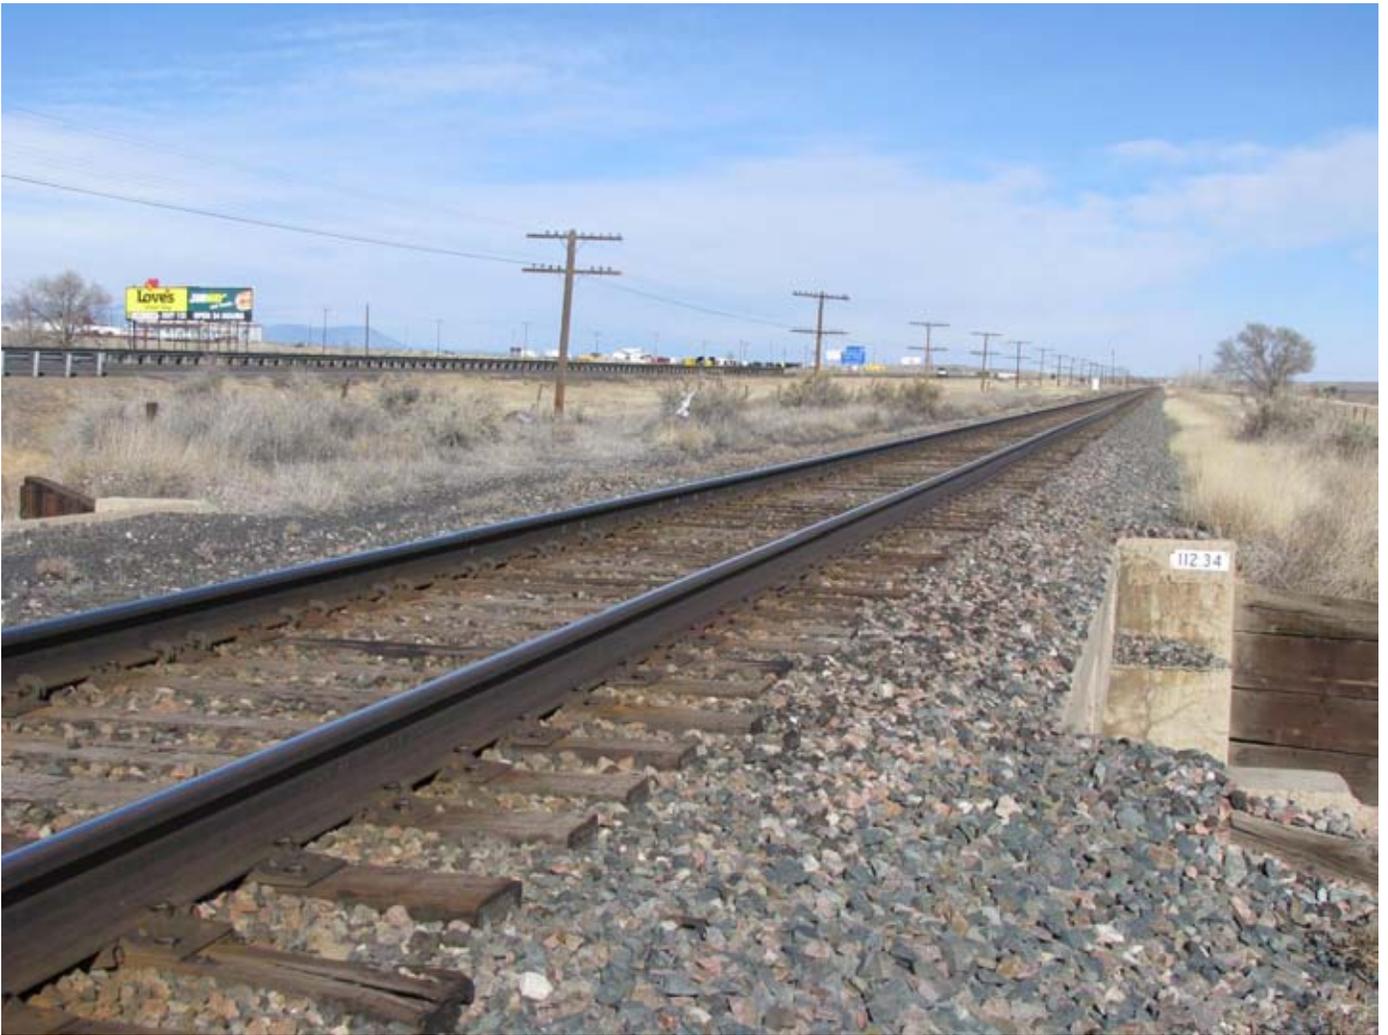
34. Describe condition: The railroad bridge is in fair condition due to portions of deteriorated concrete, which is cracked and spalled in some areas, and worn down at the corners and edges. There are missing planks from the horizontal wood-plank wing walls on the west side of the bridge due to age and deterioration. The railroad appears to have been two-track, but the western line has been removed.

Photograph 1: D&RGW Railroad Bridge 112.34, East side, View to the west.

Photograph 2: D&RGW Railroad Bridge 112.34, Structure detail, View to the northwest.

Photograph 3: D&RGW Railroad Bridge 112.34, West side, View to the east.

Photograph 4: D&RGW Railroad Bridge 112.34, Bridge deck, View to the northwest.

39. Threats to Resource: Water erosion___ Wind erosion___ Grazing___ Neglect___
Vandalism___ Recreation___ Construction___ Other (specify): _____
comments: No threats observed.
40. Existing Protection: None___ Marked___ Fenced___ Patrolled X Access controlled ___
other (specify): Railroad is monitored by the Union Pacific Railroad Company
41. Local landmark designation: n/a 42. Easement: n/a
43. Management Recommendations: Avoid, otherwise no further work.
