*Class III Cultural Resources Inventory,
Dillon Drive at I-25, Pueblo, Colorado*

FINAL

January 2009

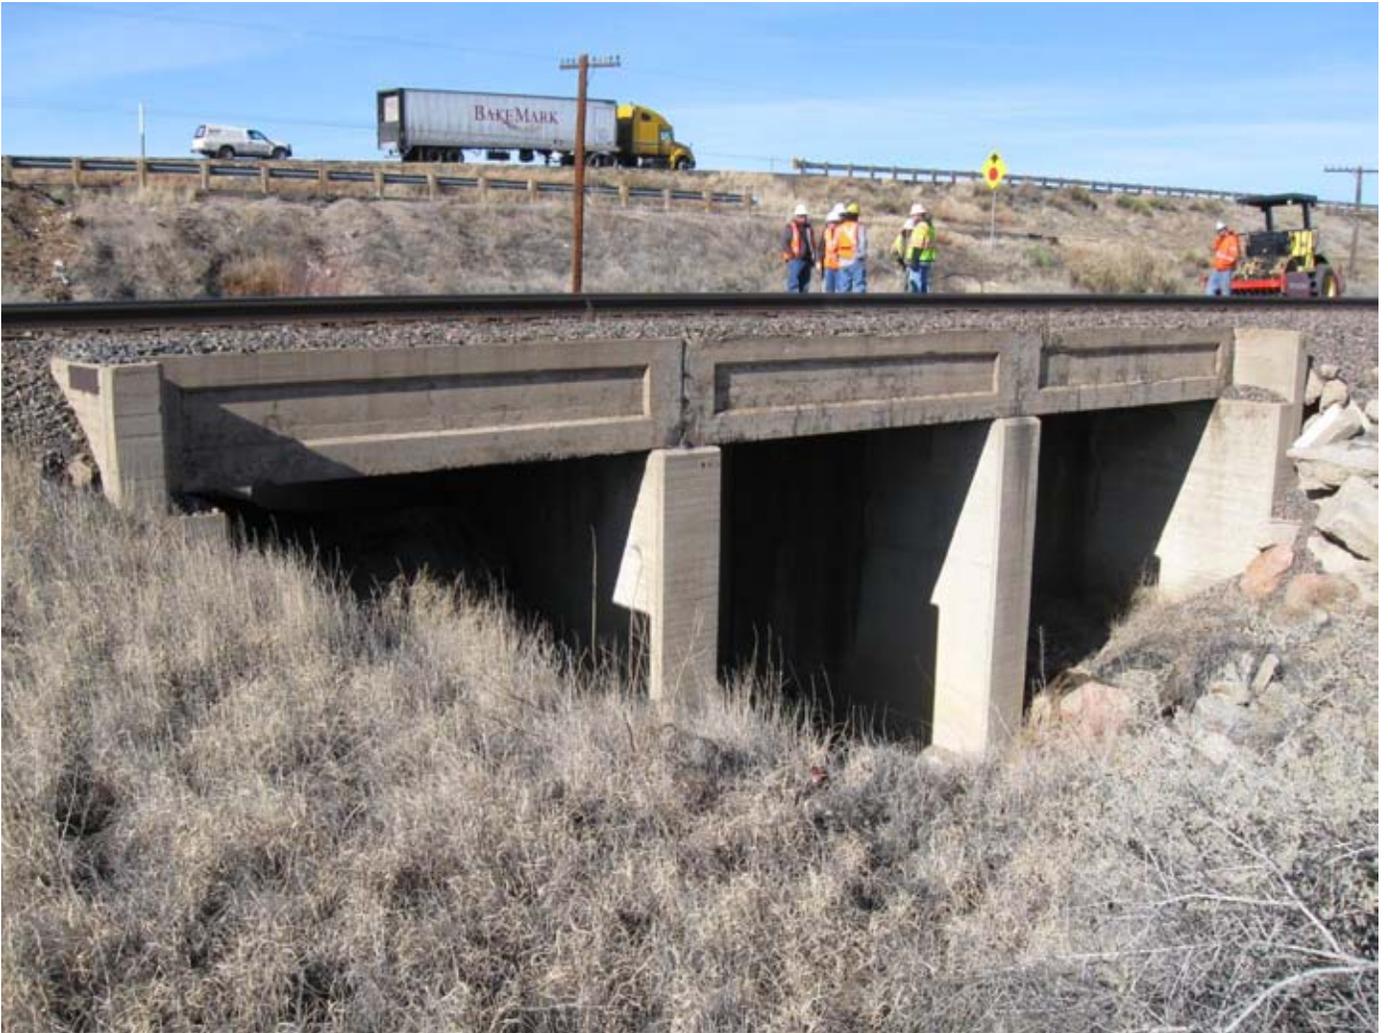
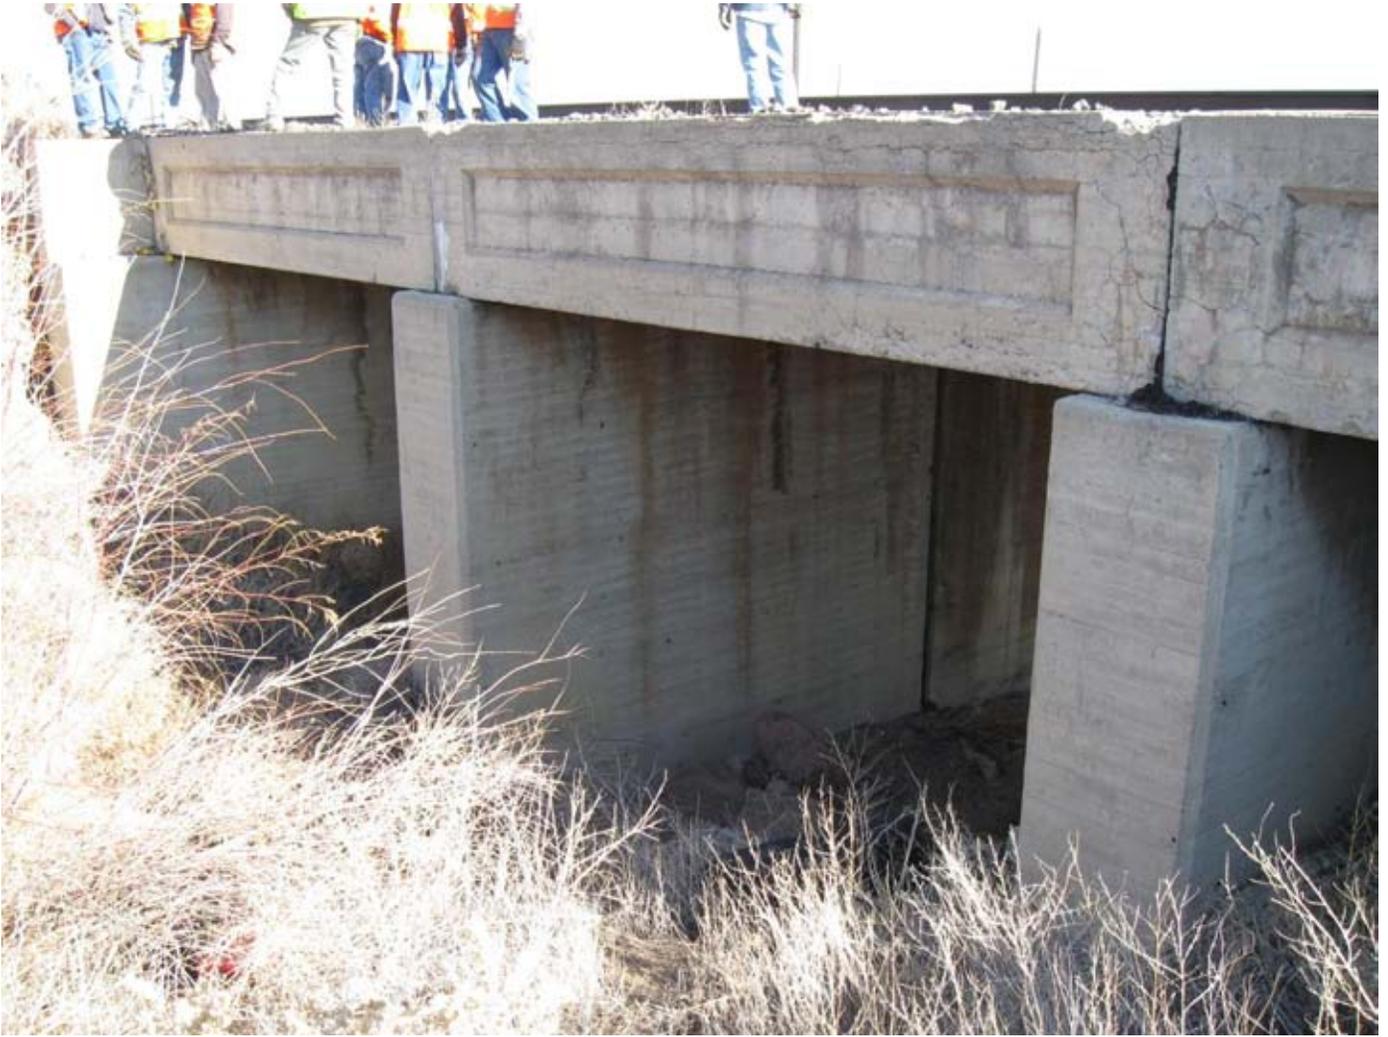
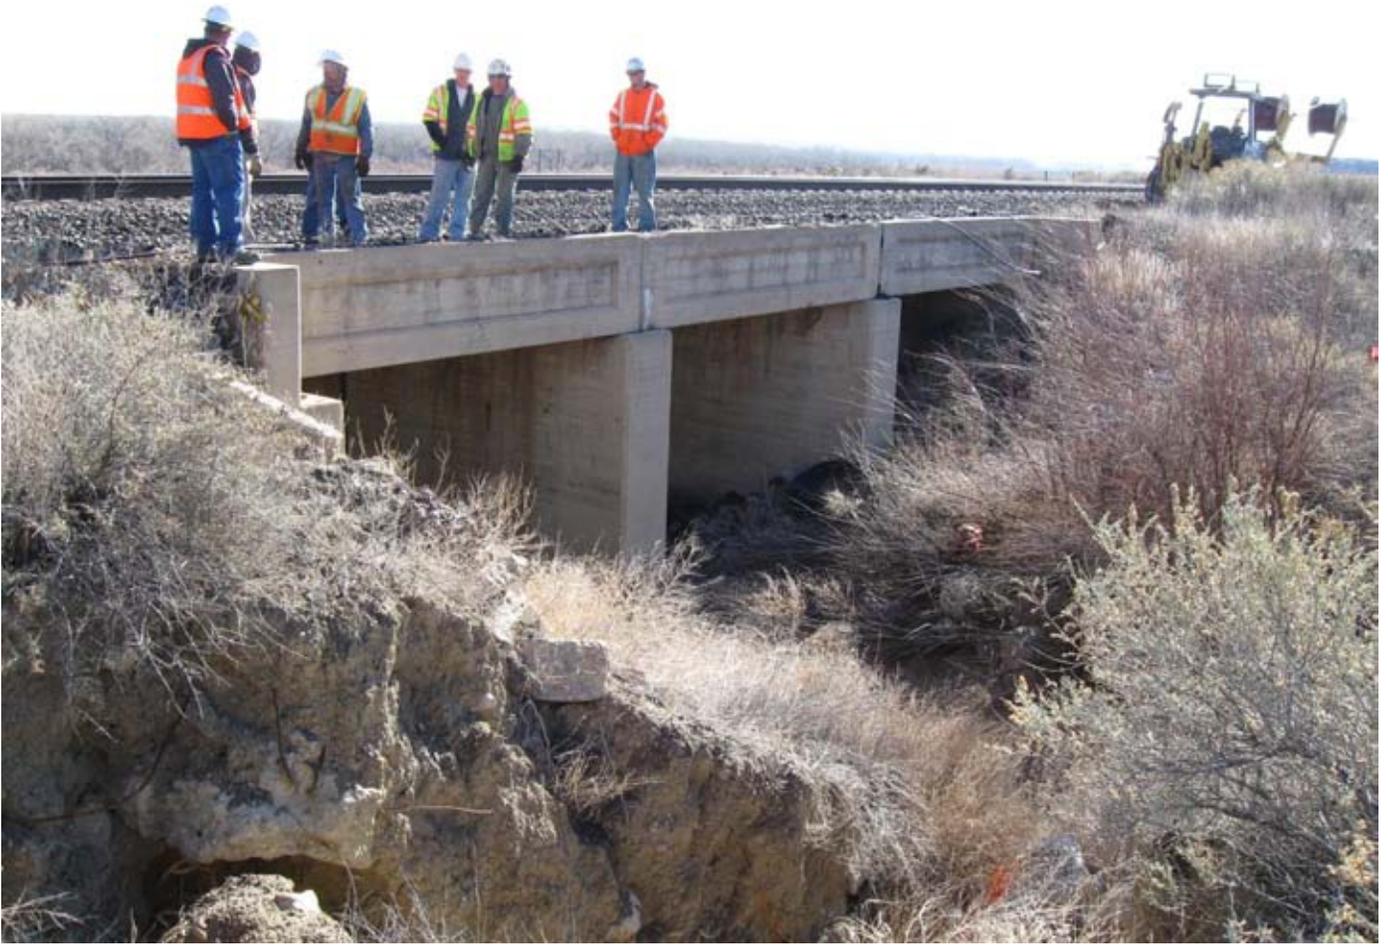
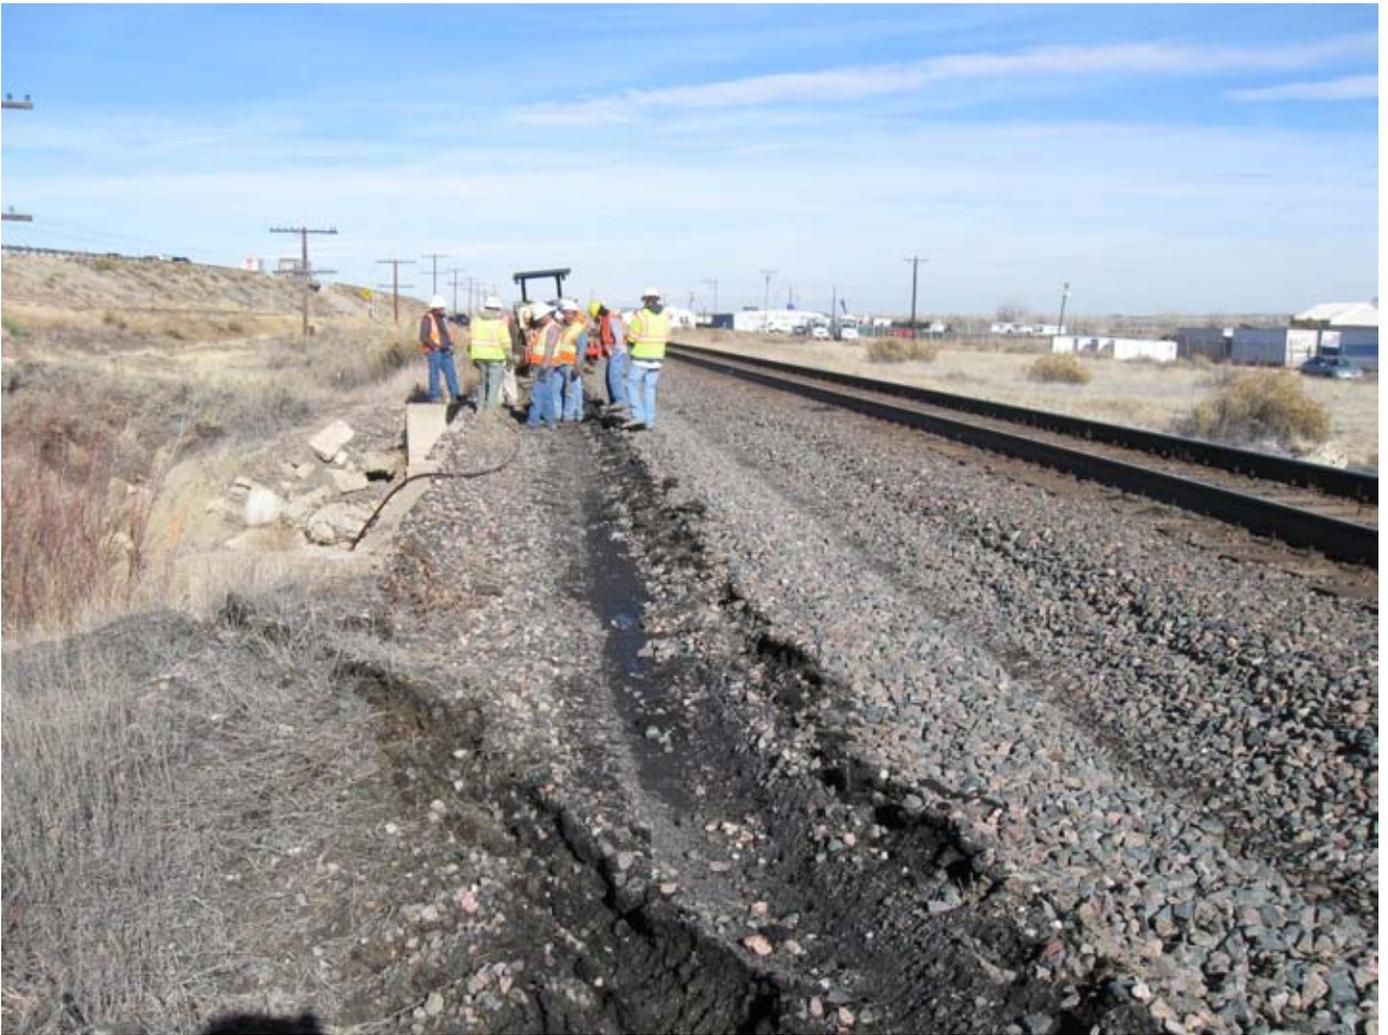
34. Describe condition: The railroad bridge is in fair condition due to portions of deteriorated concrete, which is cracked and spalled in some areas, and worn down at the corners and edges due to age and deterioration. Railroad appears to have been two-track, but the western line has been removed.

Photograph 1: D&RGW Railroad Bridge 112.78, East side, View to the northwest.

Photograph 2: D&RGW Railroad Bridge 112.78, Structure detail of west side, View to the northeast.

Photograph 3: D&RGW Railroad Bridge 112.78, West side, View to the southeast.

Photograph 4: D&RGW Railroad Bridge 112.78, Bridge deck, View to the north-northeast.

39. Threats to Resource: Water erosion___ Wind erosion___ Grazing___ Neglect___
Vandalism___ Recreation___ Construction___ Other (specify): _____
comments: No threats observed.
40. Existing Protection: None___ Marked___ Fenced___ Patrolled X Access controlled ___
other (specify): Railroad is monitored by the Union Pacific Railroad Company
41. Local landmark designation: n/a 42. Easement: n/a
43. Management Recommendations: Avoid, otherwise no further work.

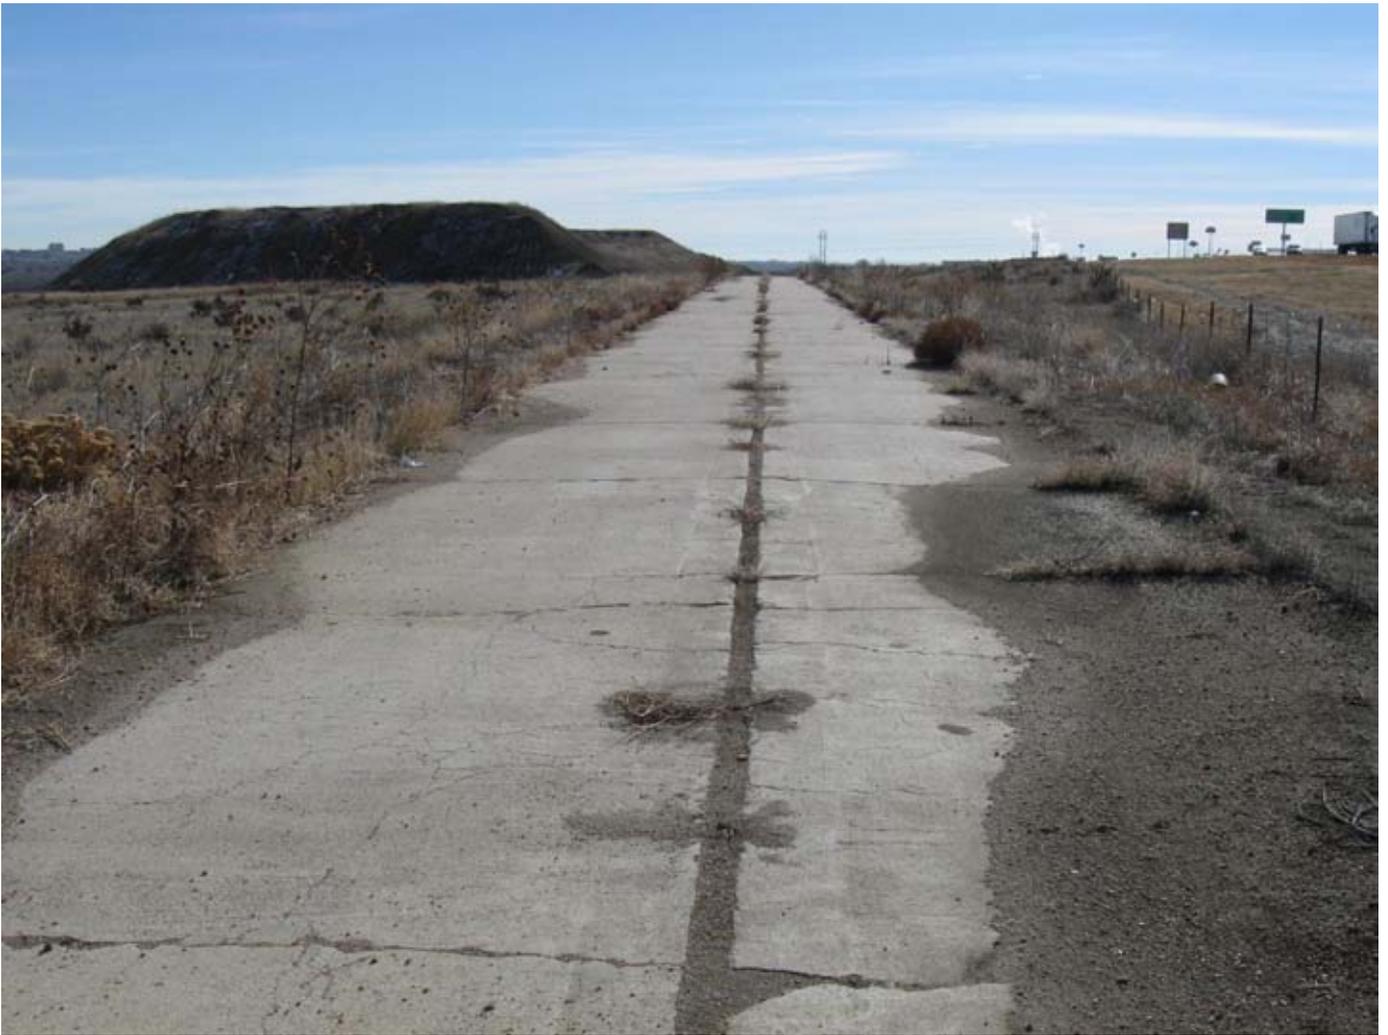
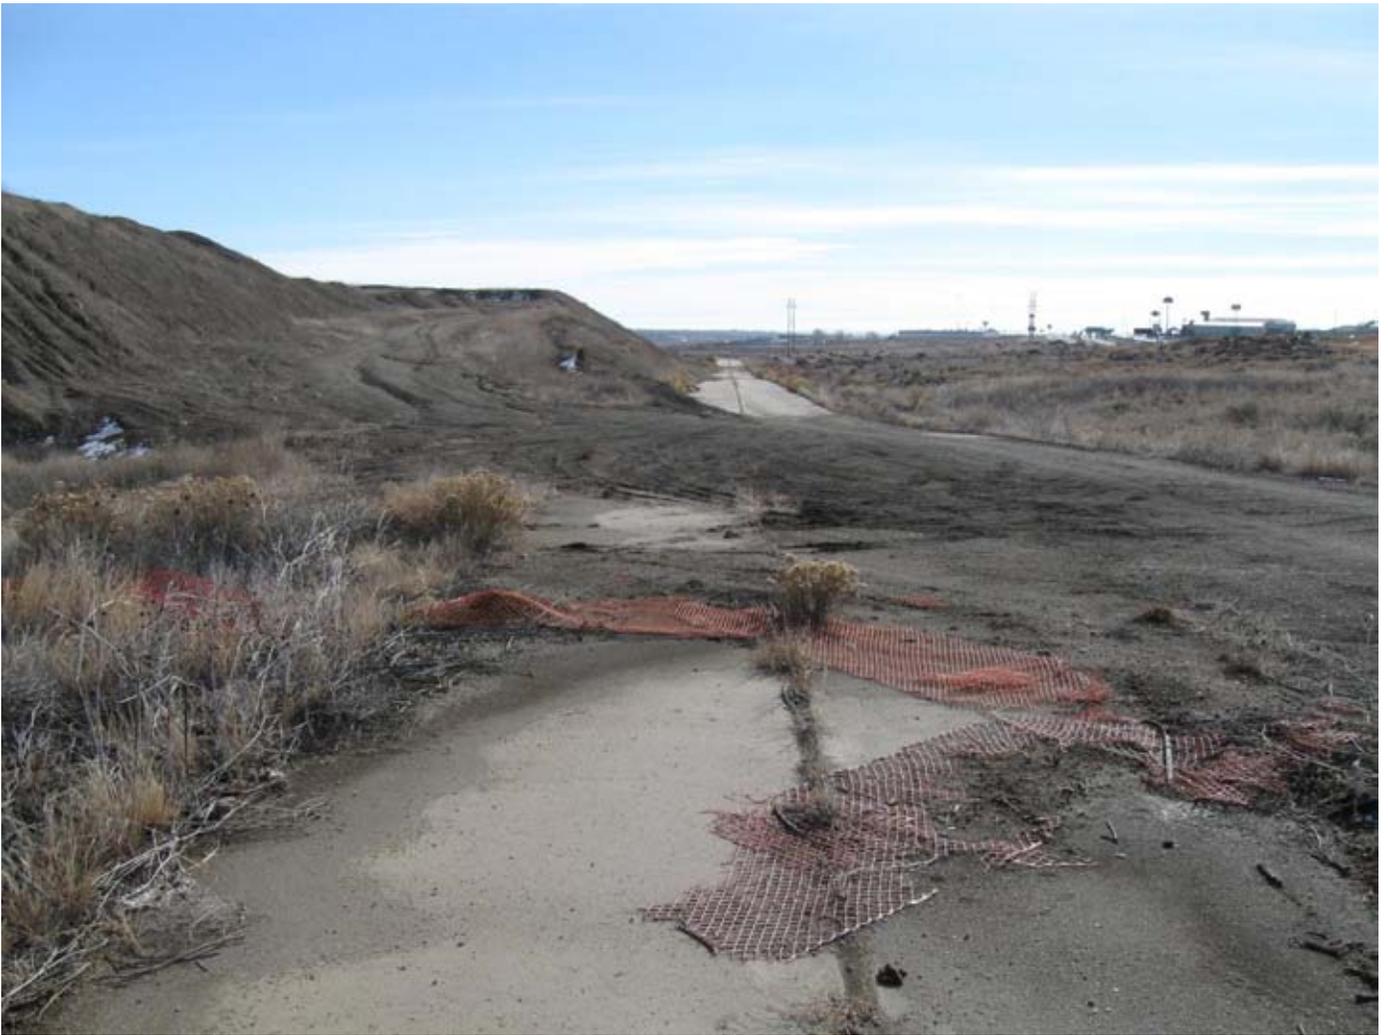
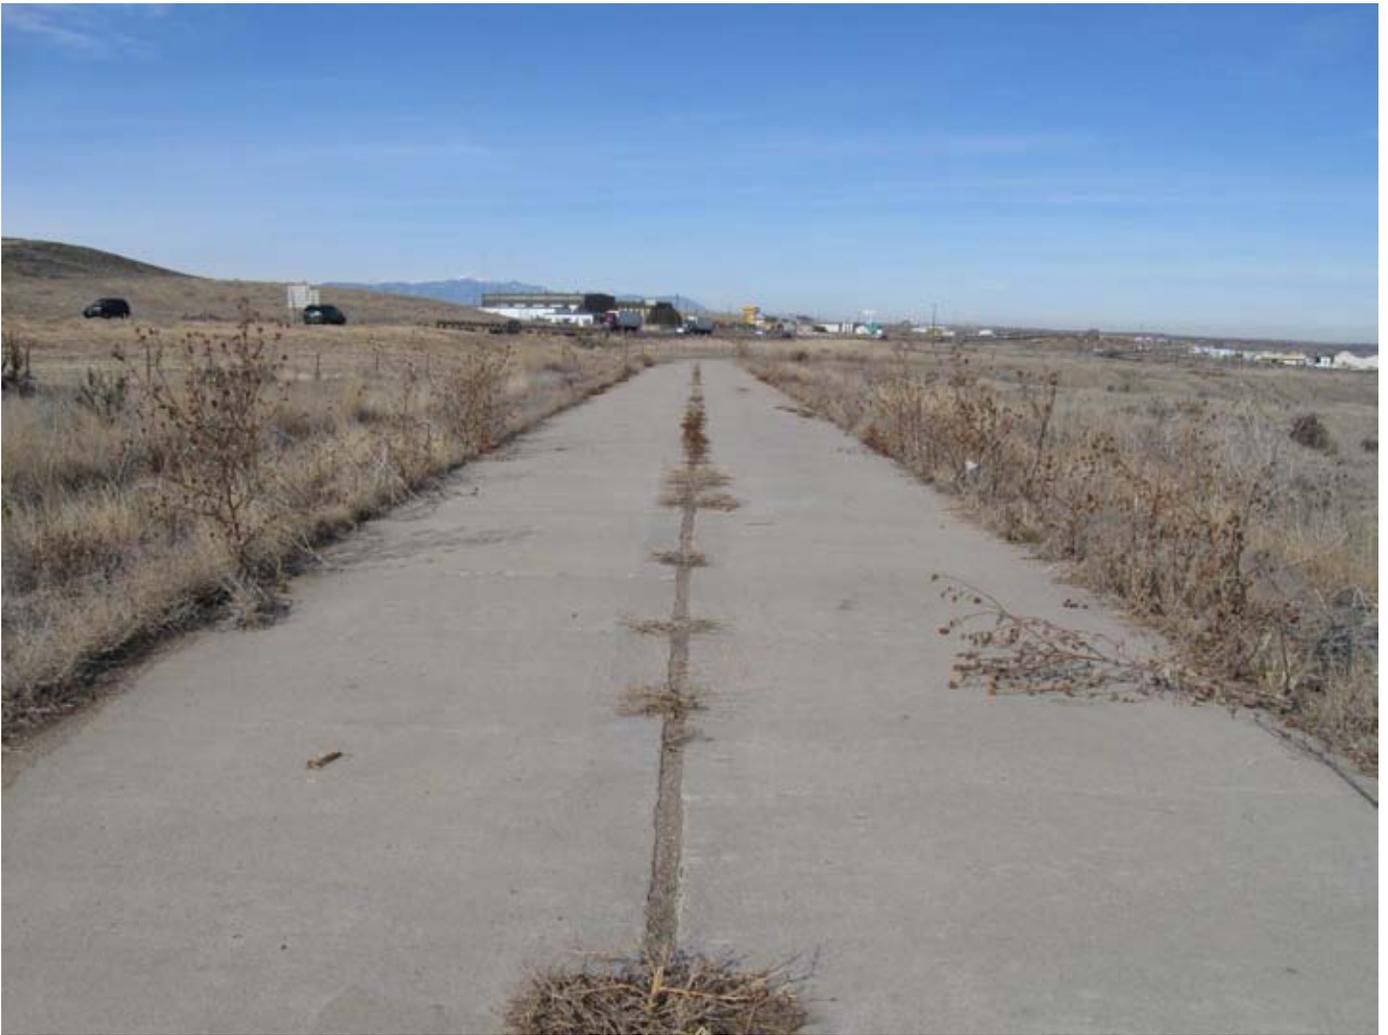
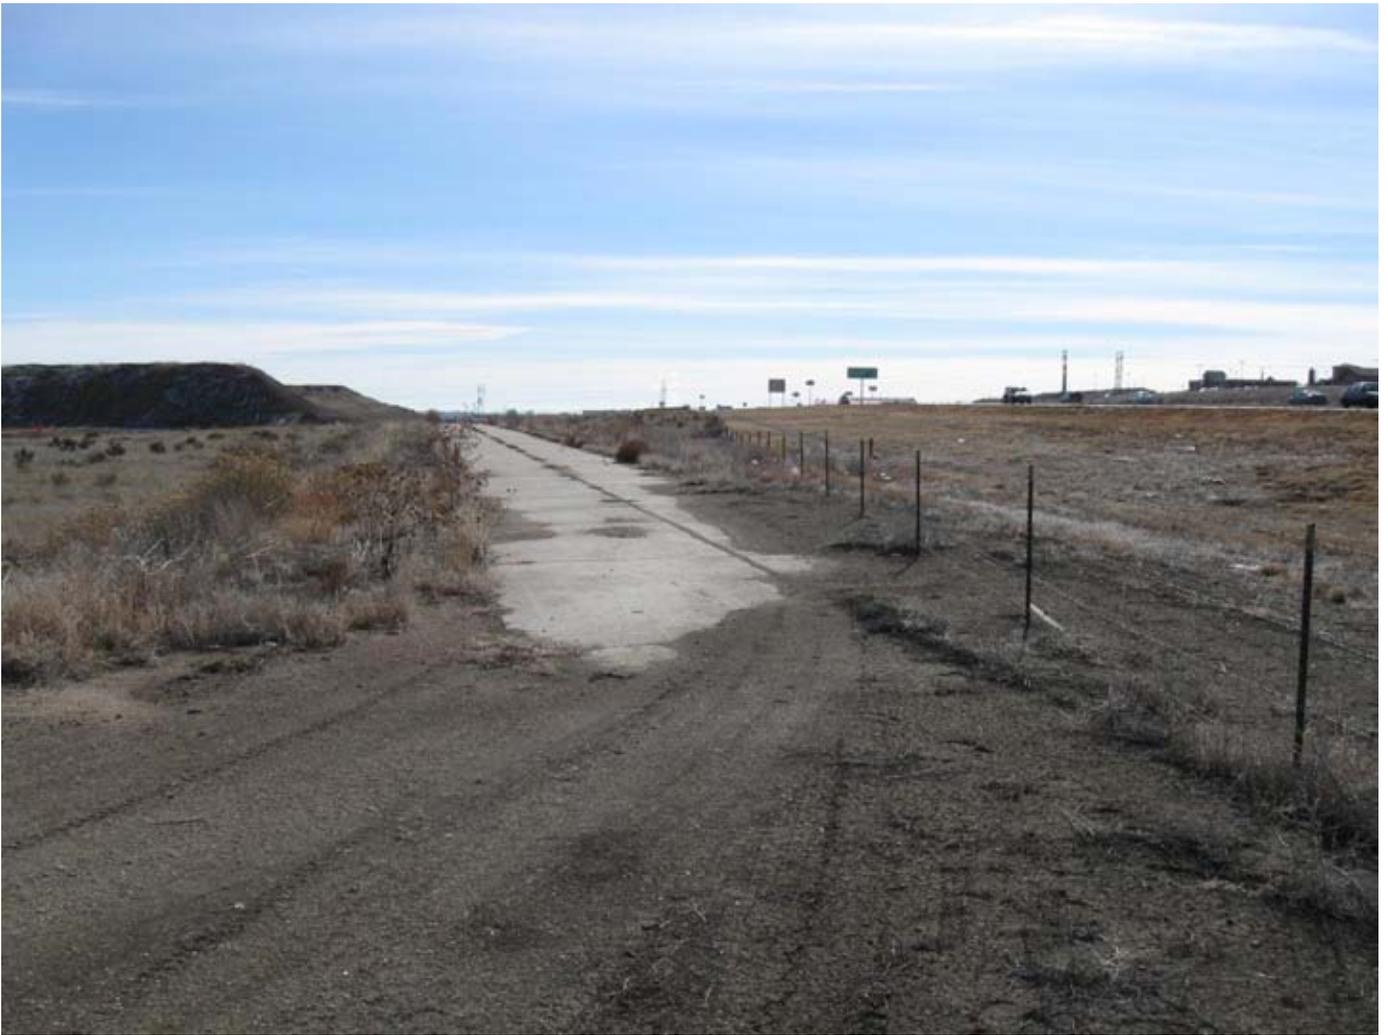
Photograph 1: US Highway 85, View to the south-southeast.

Photograph 2: US Highway 85, View to the south-southeast.

Photograph 3: US Highway 85, View toward I-25, looking north-northwest.

Photograph 4: US Highway 85, View from northern edge of the roadway, looking to south-southeast.

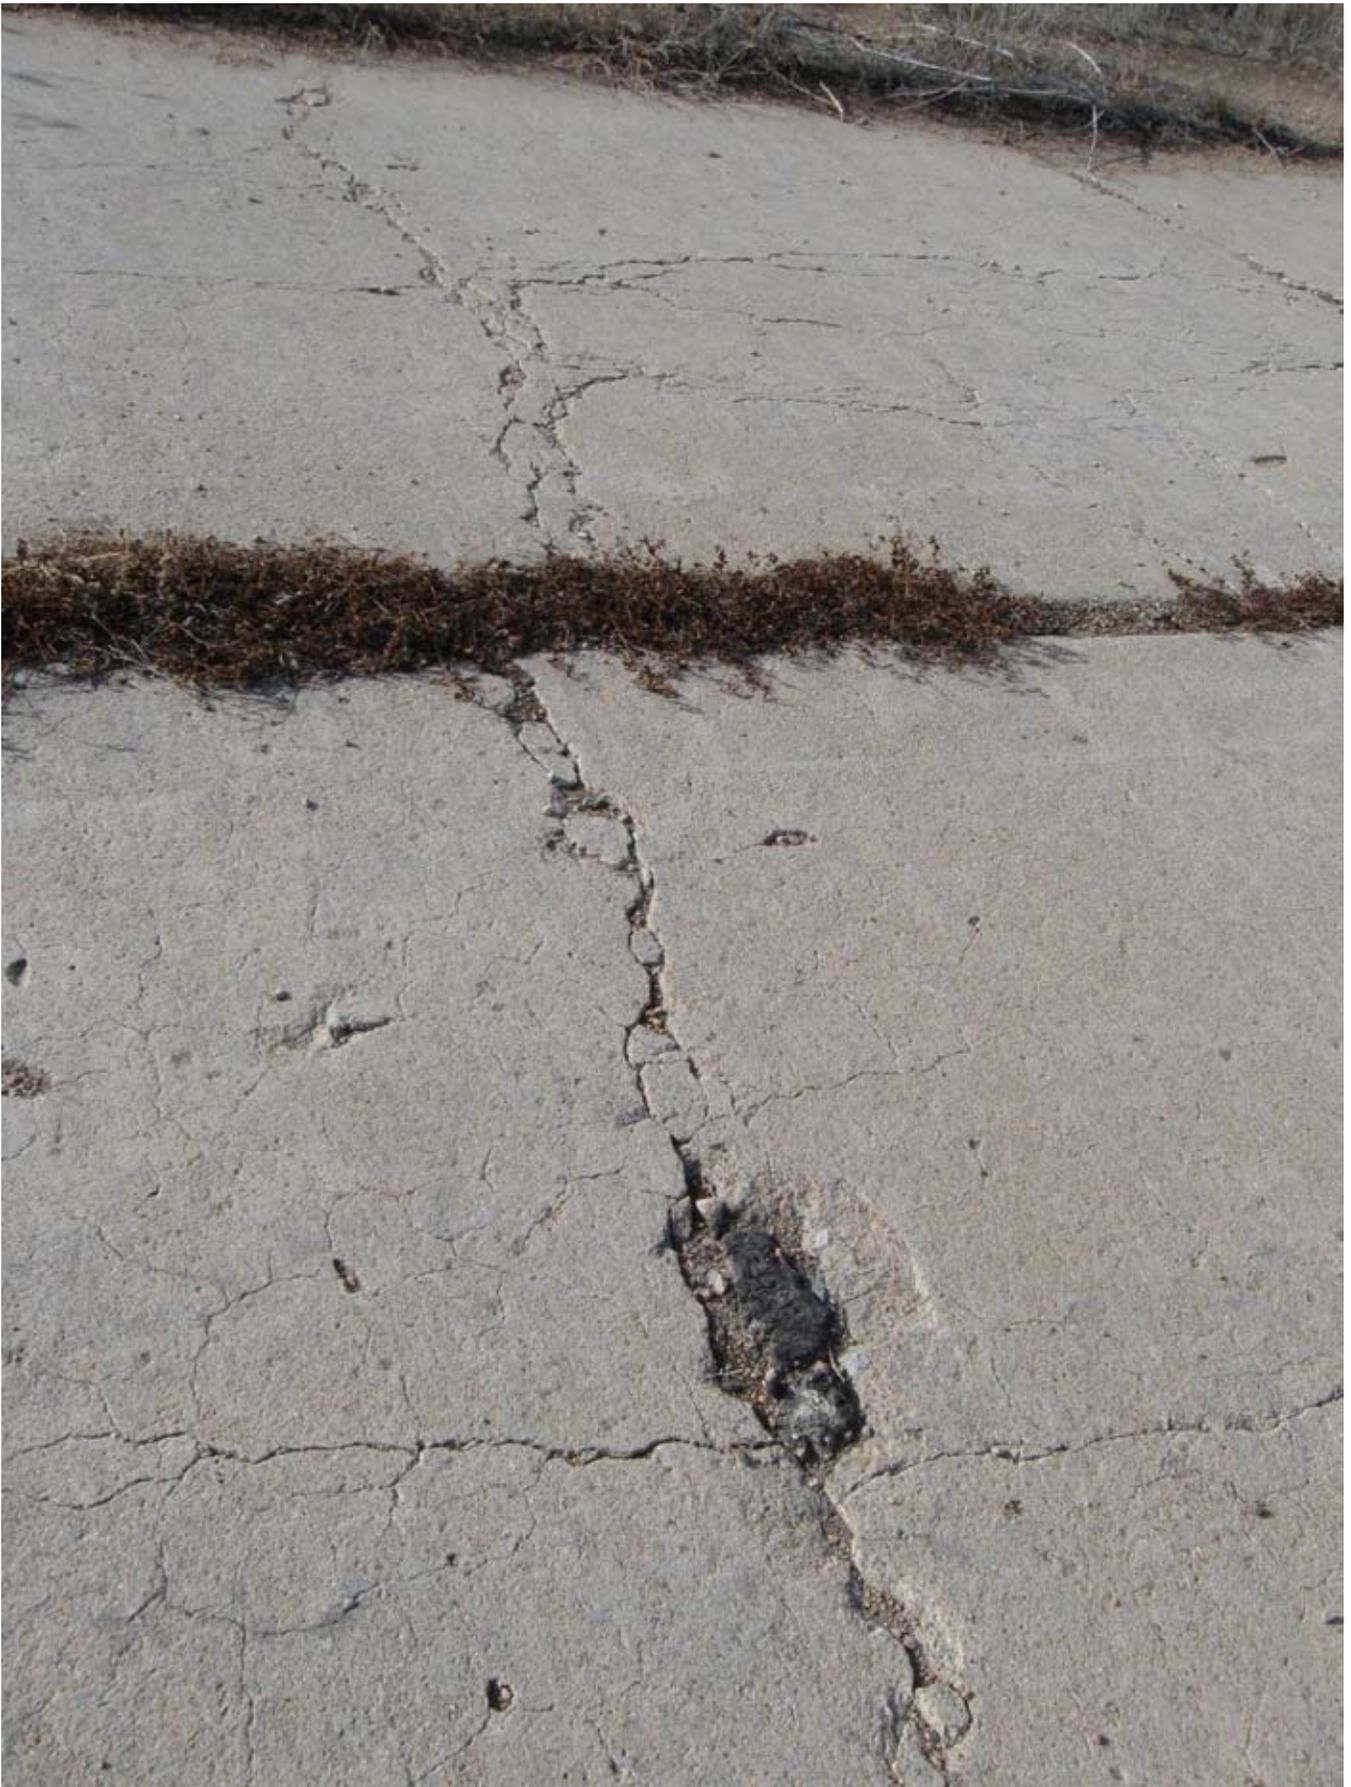
34. Describe condition: This resource is a 1,040-foot-long abandoned, two-lane highway segment that was originally built in 1930. It exhibits cracking and some spalling throughout the surface of the roadbed due to weathering, vegetative growth, and lack of maintenance.

Photograph 5: US Highway 85, Roadway detail of cracking and spalling.

39. Threats to Resource: Water erosion X Wind erosion X Grazing _____ Neglect X
Vandalism _____ Recreation _____ Construction _____ Other (specify): _____
comments: _____
40. Existing Protection: None X Marked _____ Fenced _____ Patrolled _____ Access controlled _____
other (specify): _____
41. Local landmark designation: n/a 42. Easement: n/a
43. Management Recommendations: Avoid, otherwise no further work.

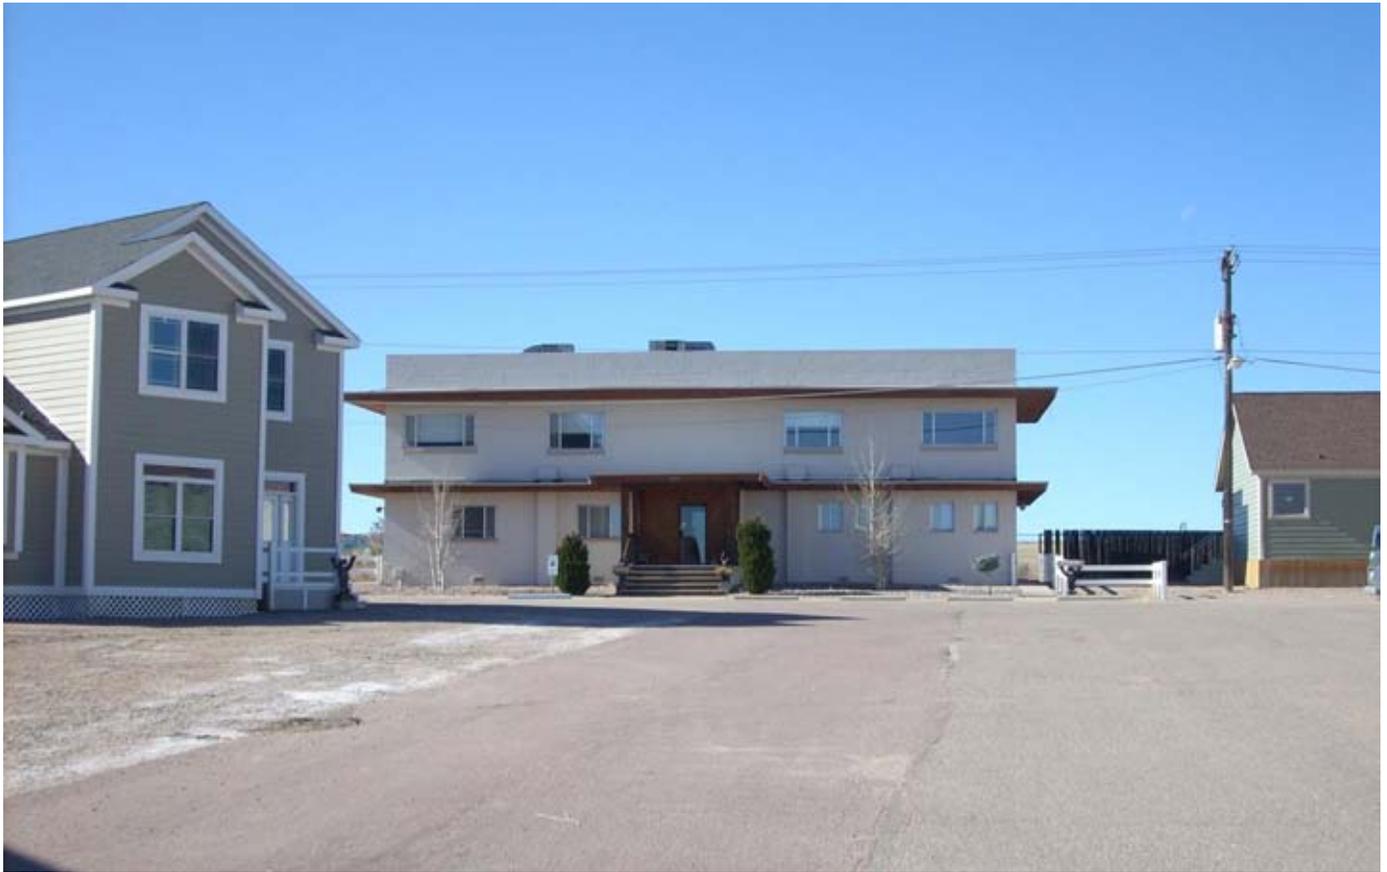
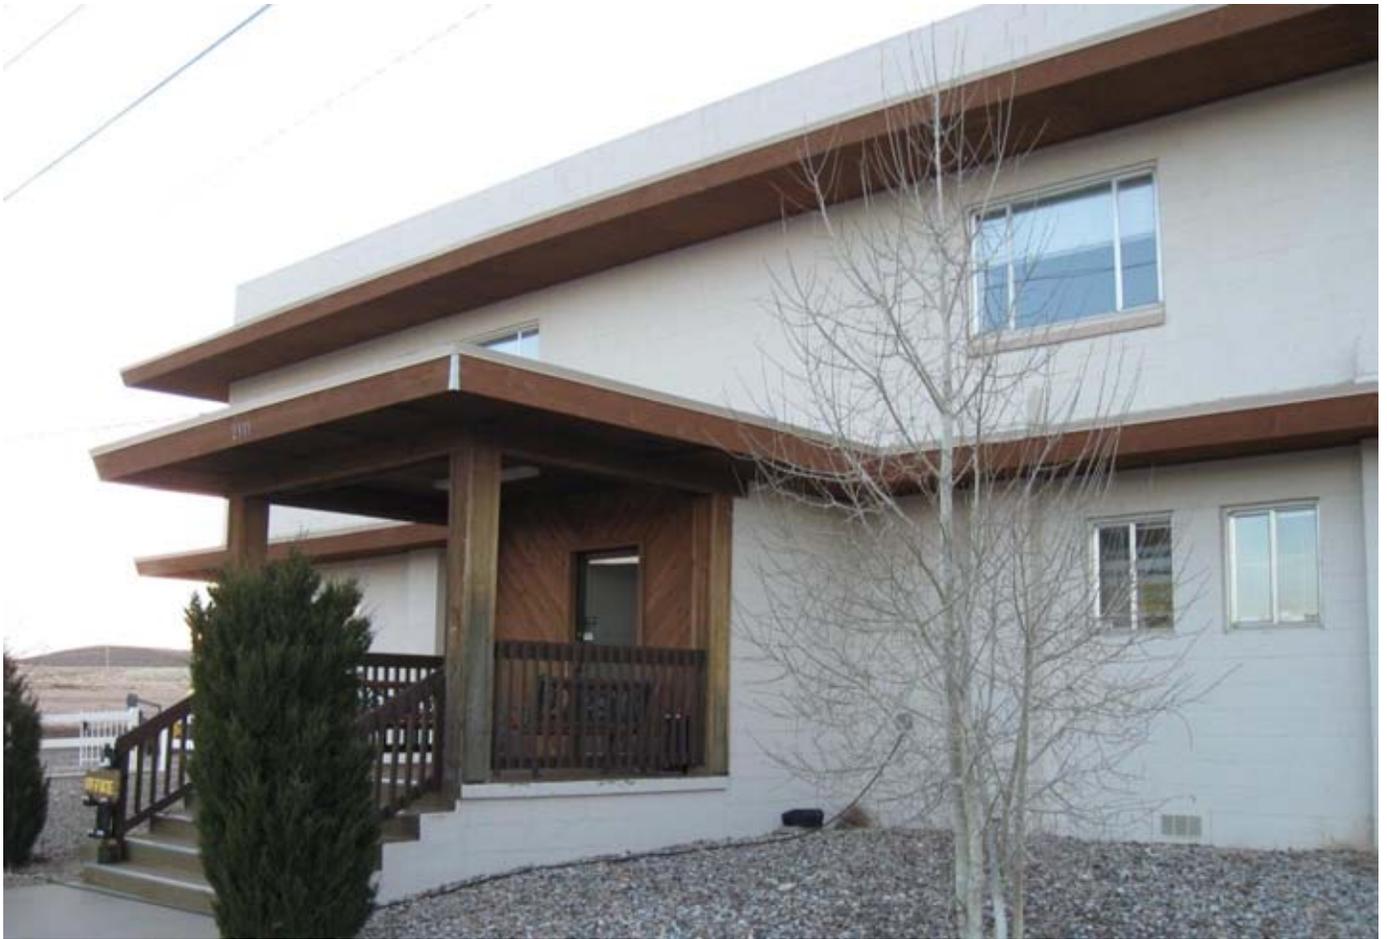
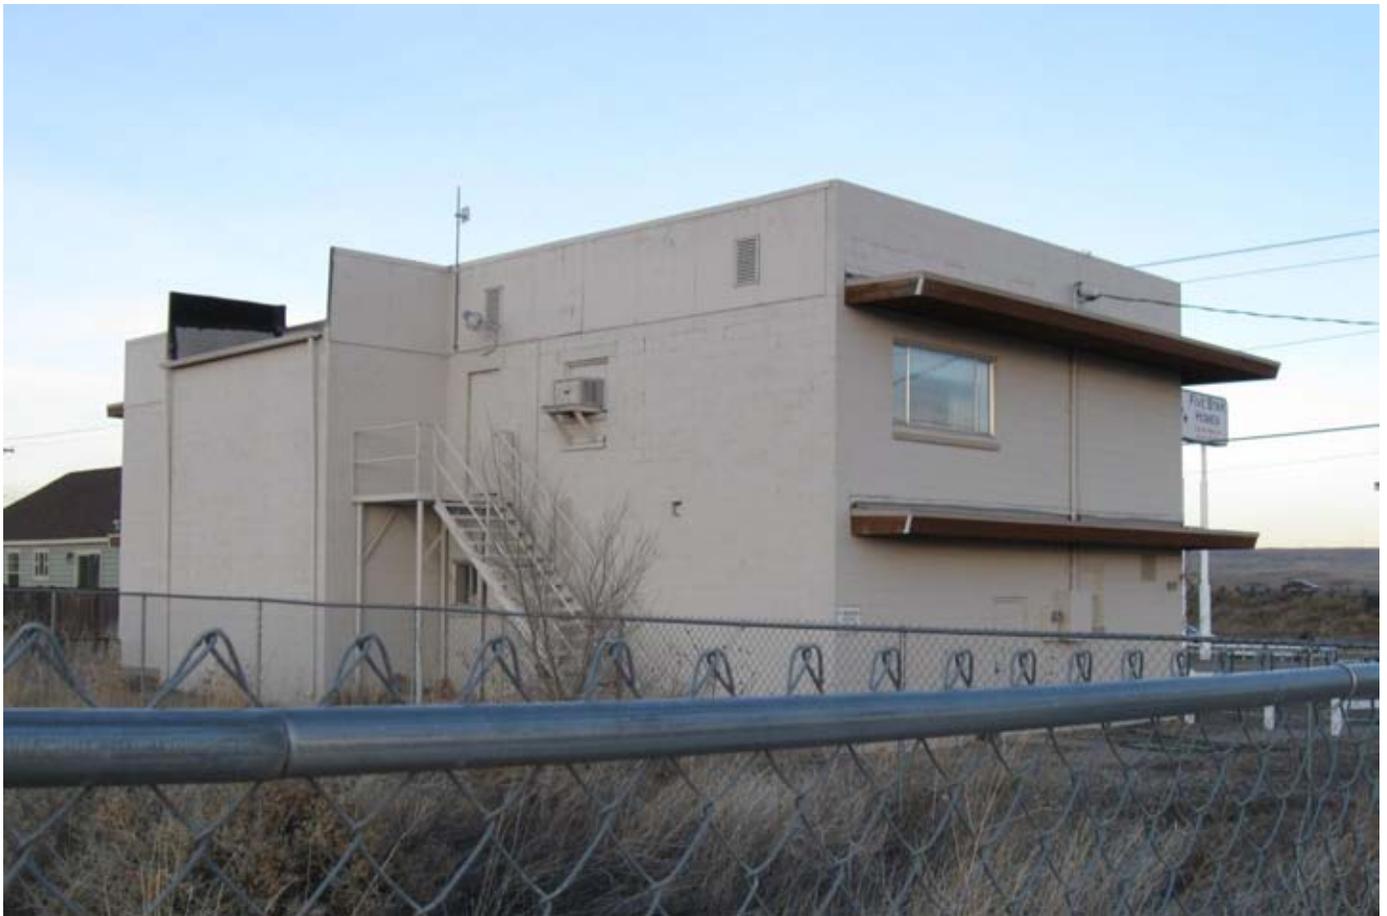
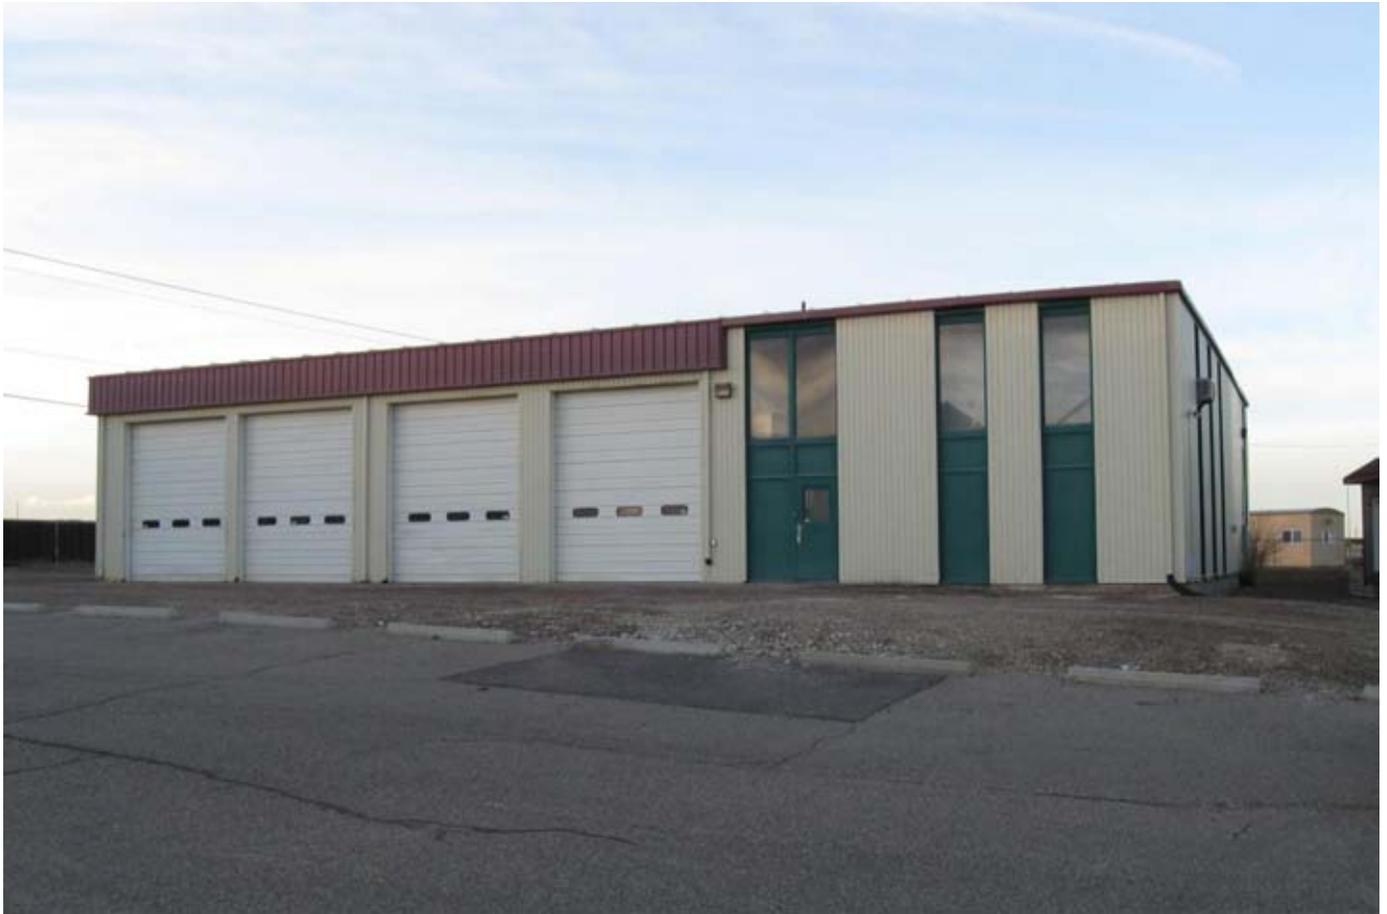
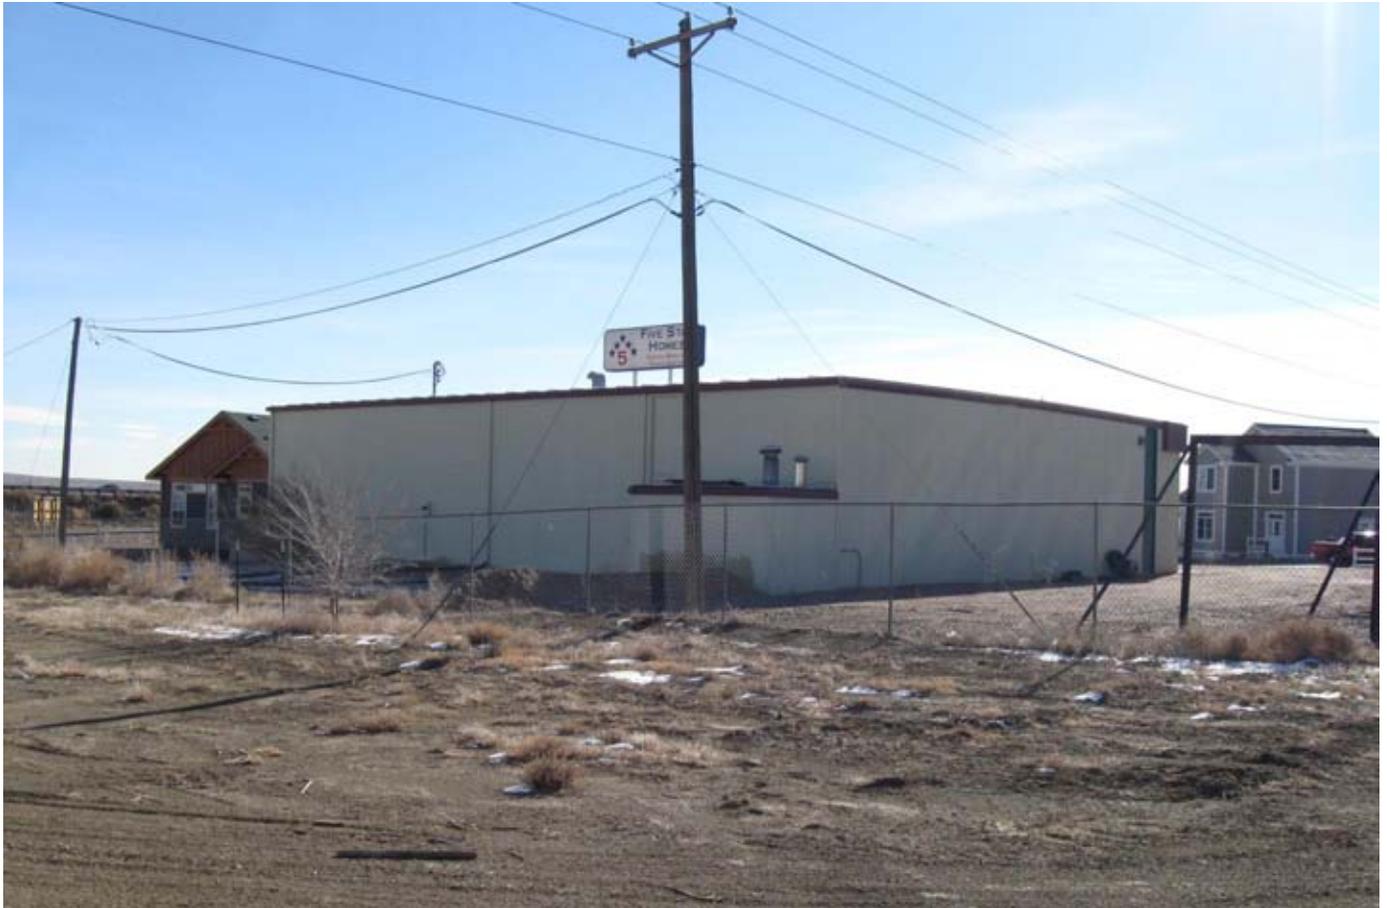
Photograph 1: Primary Building, East façade, View to the West

Photograph 2: Primary Building, East façade, View to the Southwest

Photograph 3: Primary Building, West and North facades, View to the Northeast

Photograph 4: Secondary Building, South façade, View to the North-northwest

Photograph 5: Secondary Building, North and West façades, View to the Southeast
